8900 LAKESIDE CUSTOM LOT SUBDIVISION

SPECIAL
PACKETS
PACKAGE

TENTATIVE SUBDIVISION MAP APPLICATION – SPECIAL PACKET

GEOLOGIC AND SEISMIC HAZARDS REPORT
8900 LAKESIDE DRIVE PROPERTY
APN 041-130-58
RENO, WASHOE COUNTY, NEVADA

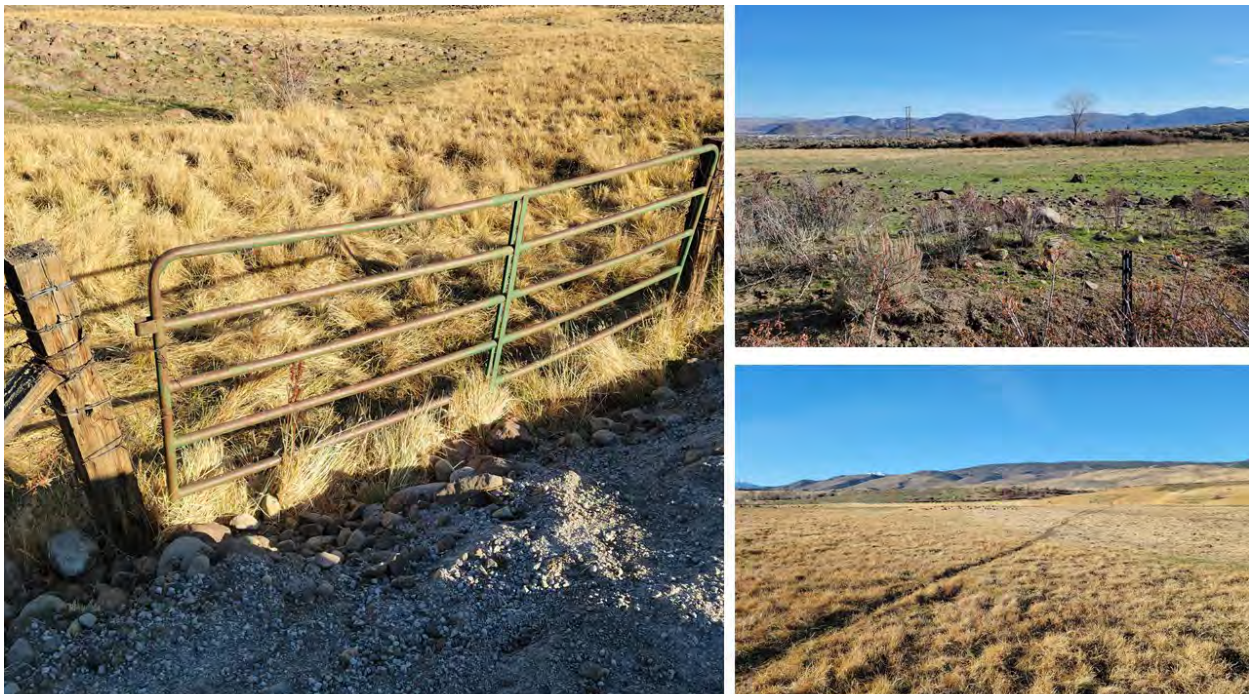
Figure 1: Grasslands throughout site.

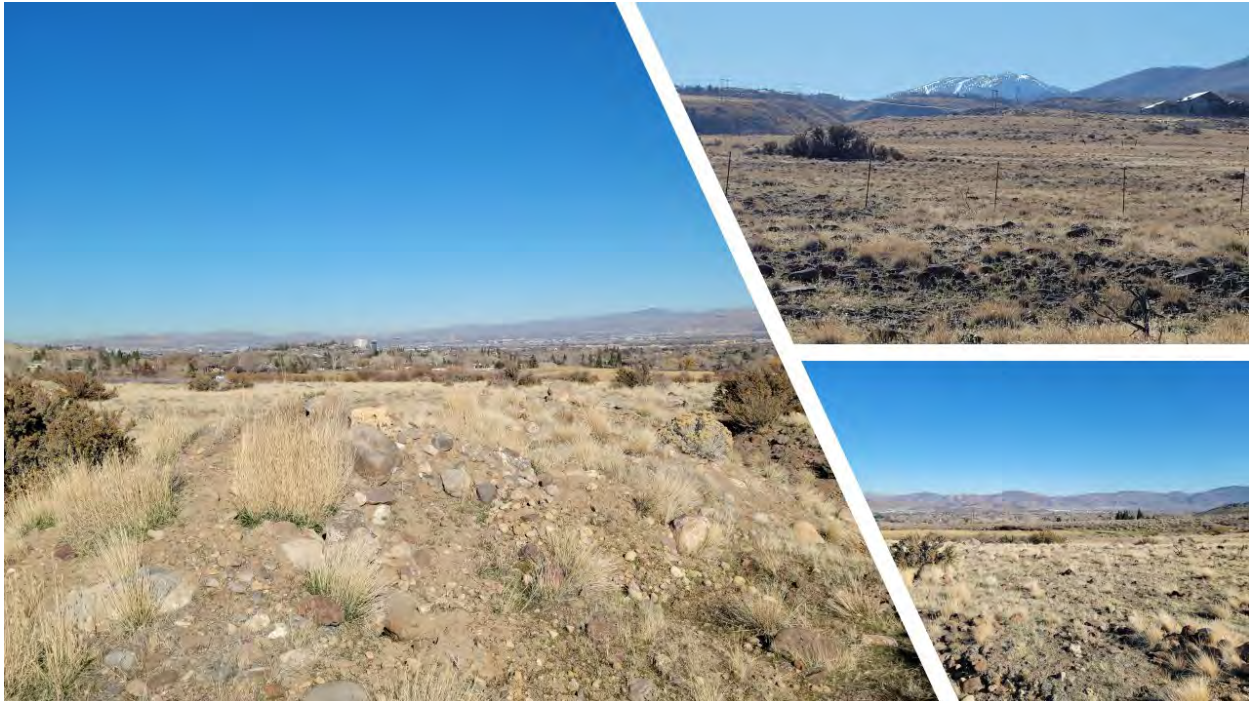
Figure 2: Boulders and cobbles on the surface of the site.

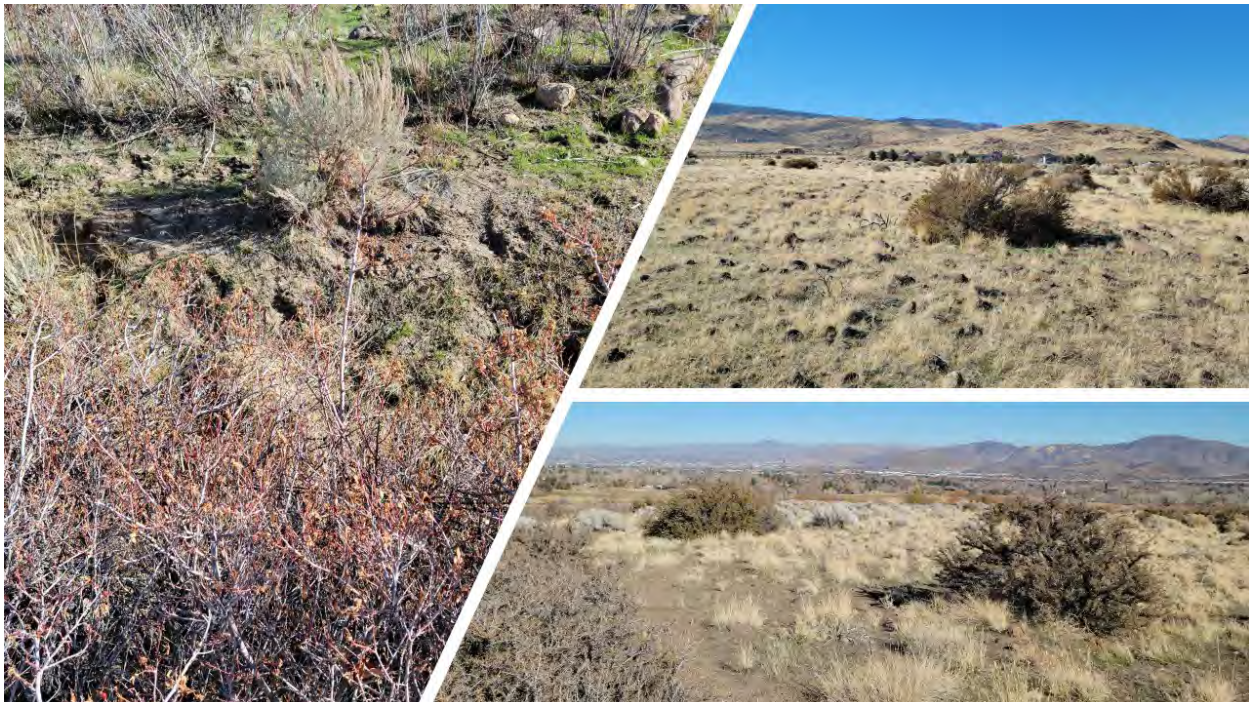
Figure 3: Various growth of vegetation throughout site.

- The terrain is varying degrees of grassland covered with boulders and cobbles (Figure 1 and 2)
 - There is moderate vegetation (Figure 3)
- Currently, the project site has:

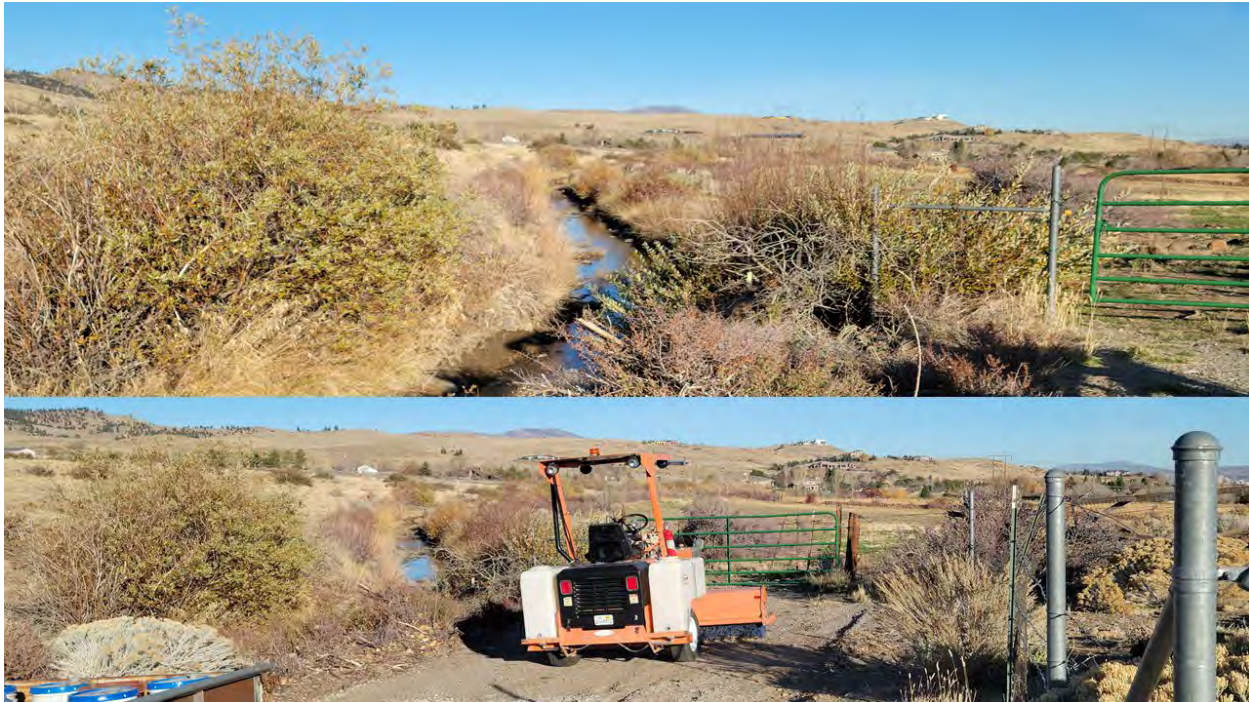
Figure 4: The entrance to the path through the site, as well as one of the waterways.

- Waterways and ditches in multiple locations throughout the site
 - Rockery walls found in the central section
 - A gated path running north to south through the project site connects Lombardi Road and Bellhaven Road (entrance shown in Figure 4)

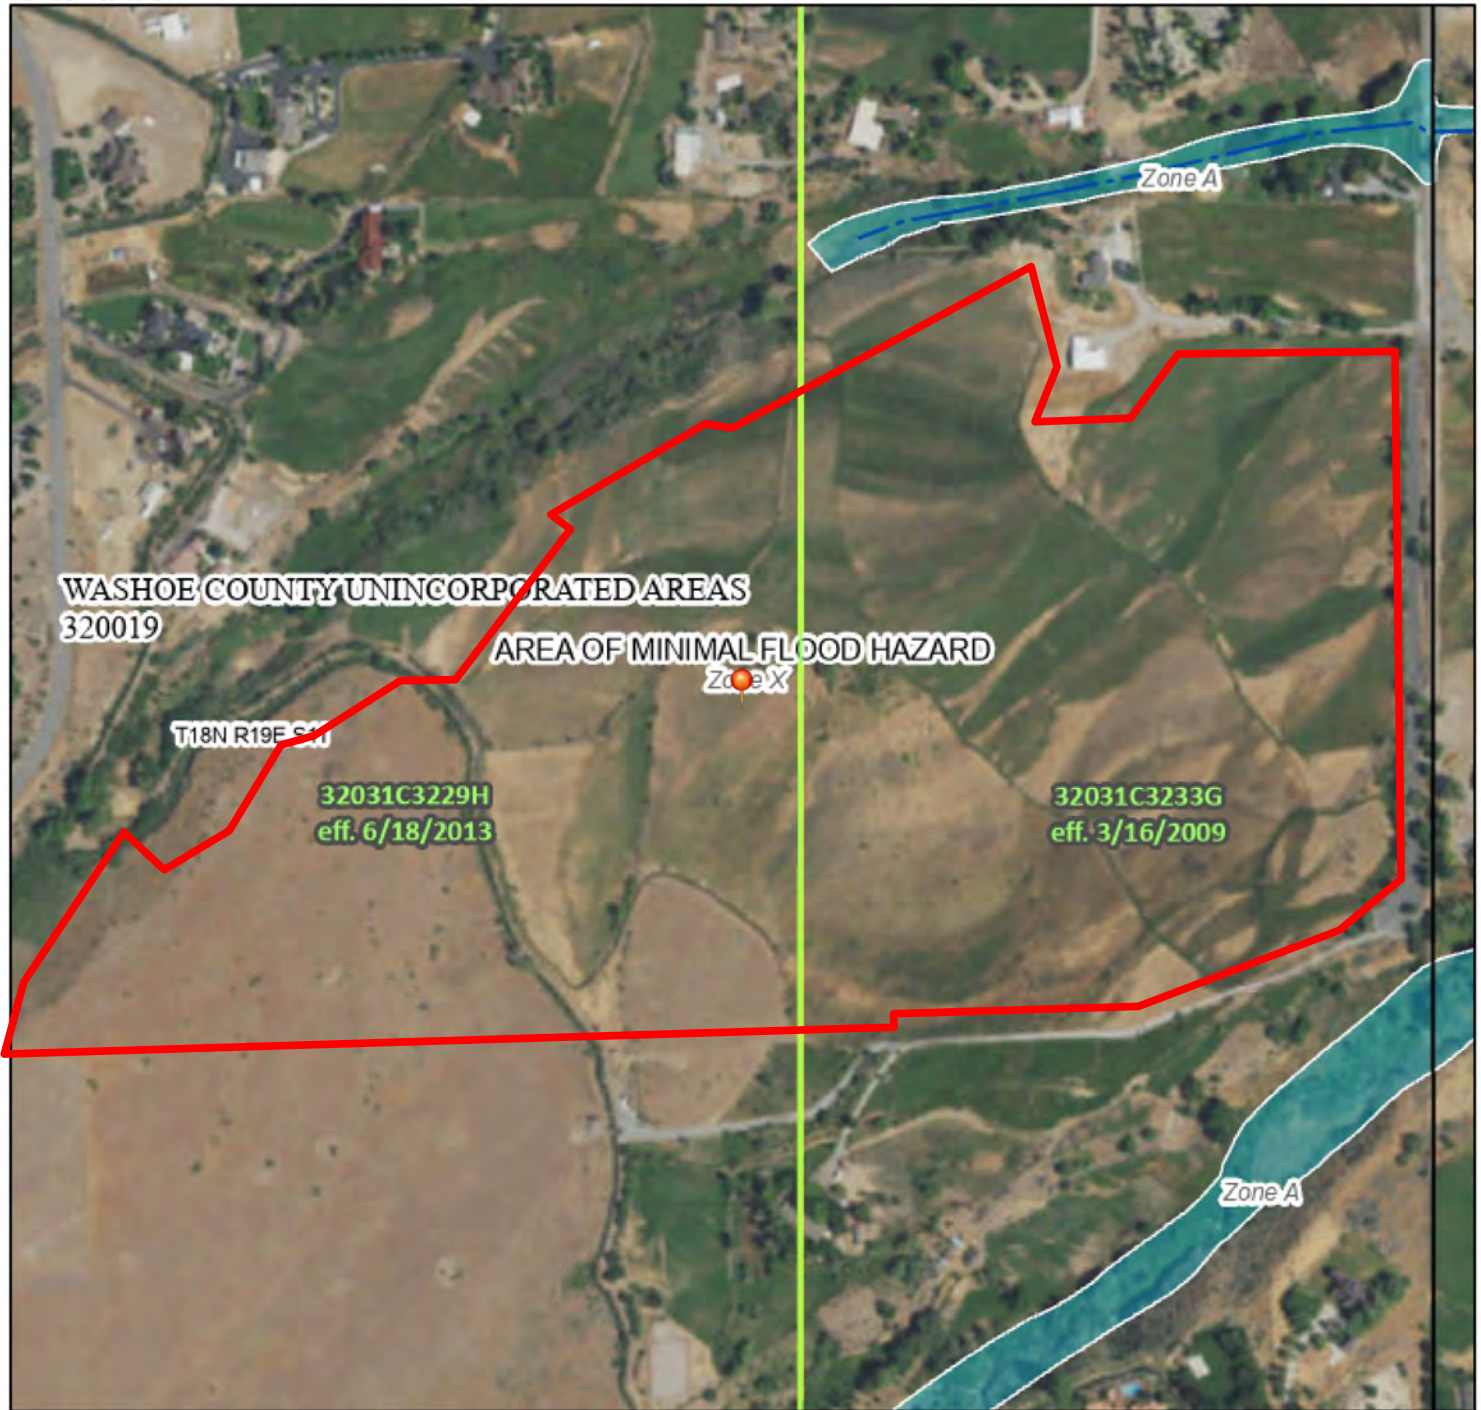
Flood Hazard Map
8900 Lakeside Drive
Washoe County, Nevada

Area of Minimal Flood Hazard

The site is located on Federal Emergency Management Agency (FEMA) community panel numbers 32031C3229H (effective 6/18/2013) and 32031C3233G (effective 3/16/2009), which map the site is within **flood hazard Zone X** (unshaded). These are areas of minimal flood hazard, determined to be outside the 0.2 percent annual chance floodplain (500-year flood) and areas of 1 percent annual chance flood (100-year flood). A copy of the flood hazard map is included on Plate A-4, Flood Hazard Map.

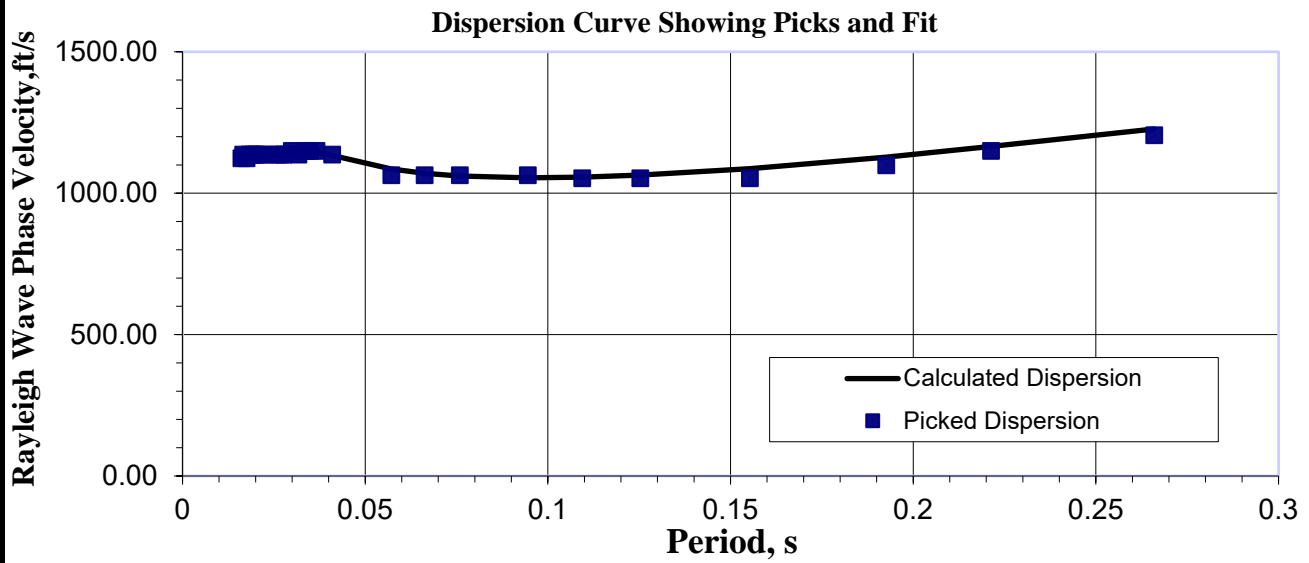
p-f Image with Dispersion Modeling Picks

CLIENT: Thomas Creek Development, LLC	Dispersion Curve and p-f Image (Line 2)	
	PROJECT: 8900 Lakeside Drive	PROJECT NO: 4130.2100074	PLATE NO: B-4

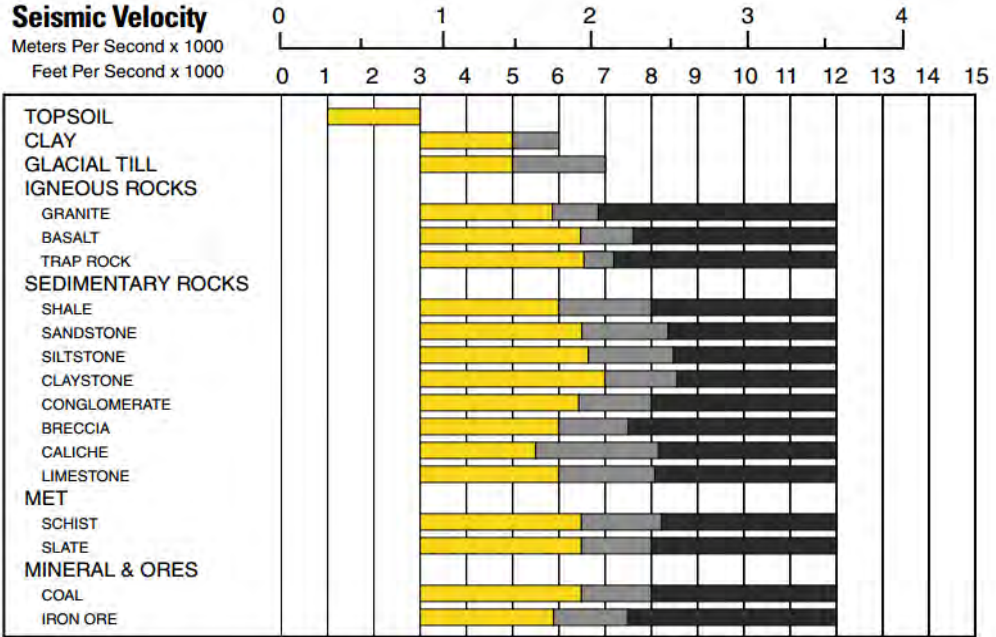
RIPPABLE
 MARGINAL
 NON-RIPPABLE

CLIENT:	Thomas Creek Development, LLC	
	PROJECT:	8900 Lakeside Drive	
		Rippability Chart	
		PROJECT NO.:	PLATE NO.
		4130.2100074	B-6

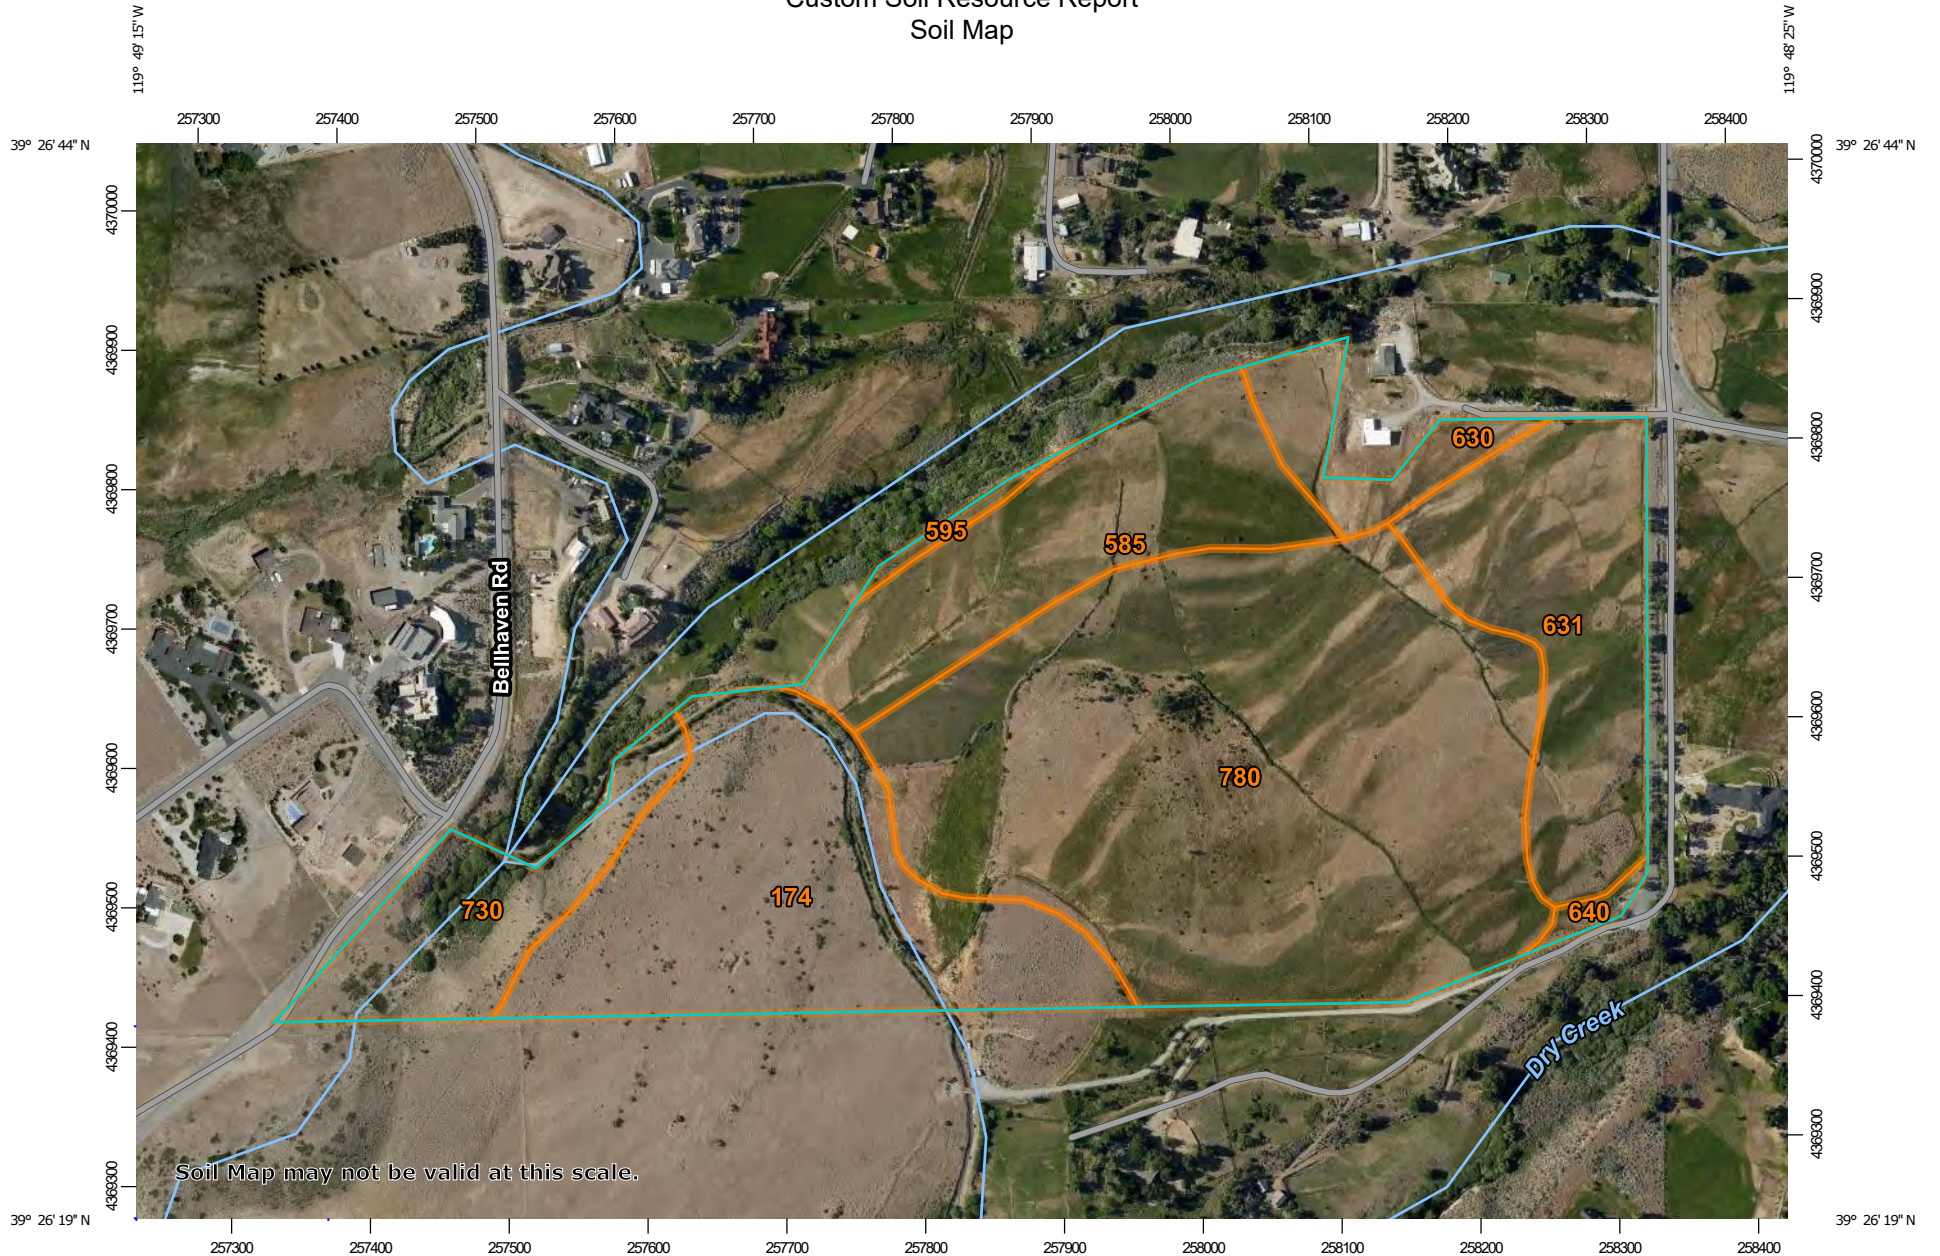
Custom Soil Resource Report Soil Map

The soil map section includes the soil map for the defined area of interest, a list of soil map units on the map and extent of each map unit, and cartographic symbols displayed on the map. Also presented are various metadata about data used to produce the map, and a description of each soil map unit.

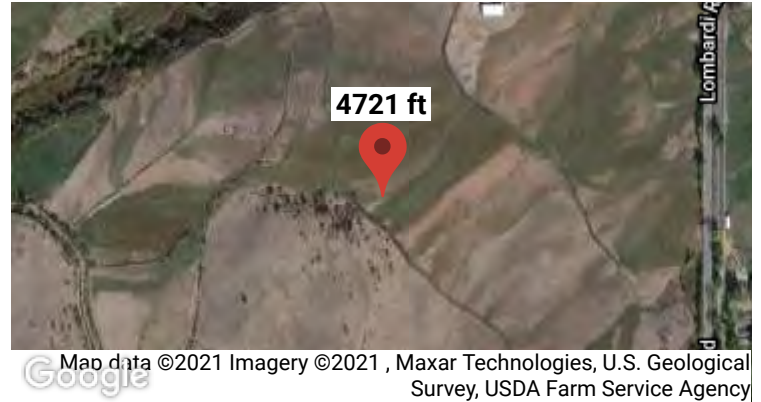
Coordinates: 39.442308060717124, -119.81169212009888
Elevation: 4721 ft
Timestamp: 2021-11-24T18:19:11.585Z
Hazard Type: Seismic
Reference Document: ASCE7-16
Risk Category: II
Site Class: D

Name	Value	Description
S_S	1.956	MCE_R ground motion (period=0.2s)
S_1	0.698	MCE_R ground motion (period=1.0s)
S_{MS}	1.956	Site-modified spectral acceleration value
S_{M1}	* null	Site-modified spectral acceleration value
S_{DS}	1.304	Numeric seismic design value at 0.2s SA
S_{D1}	* null	Numeric seismic design value at 1.0s SA

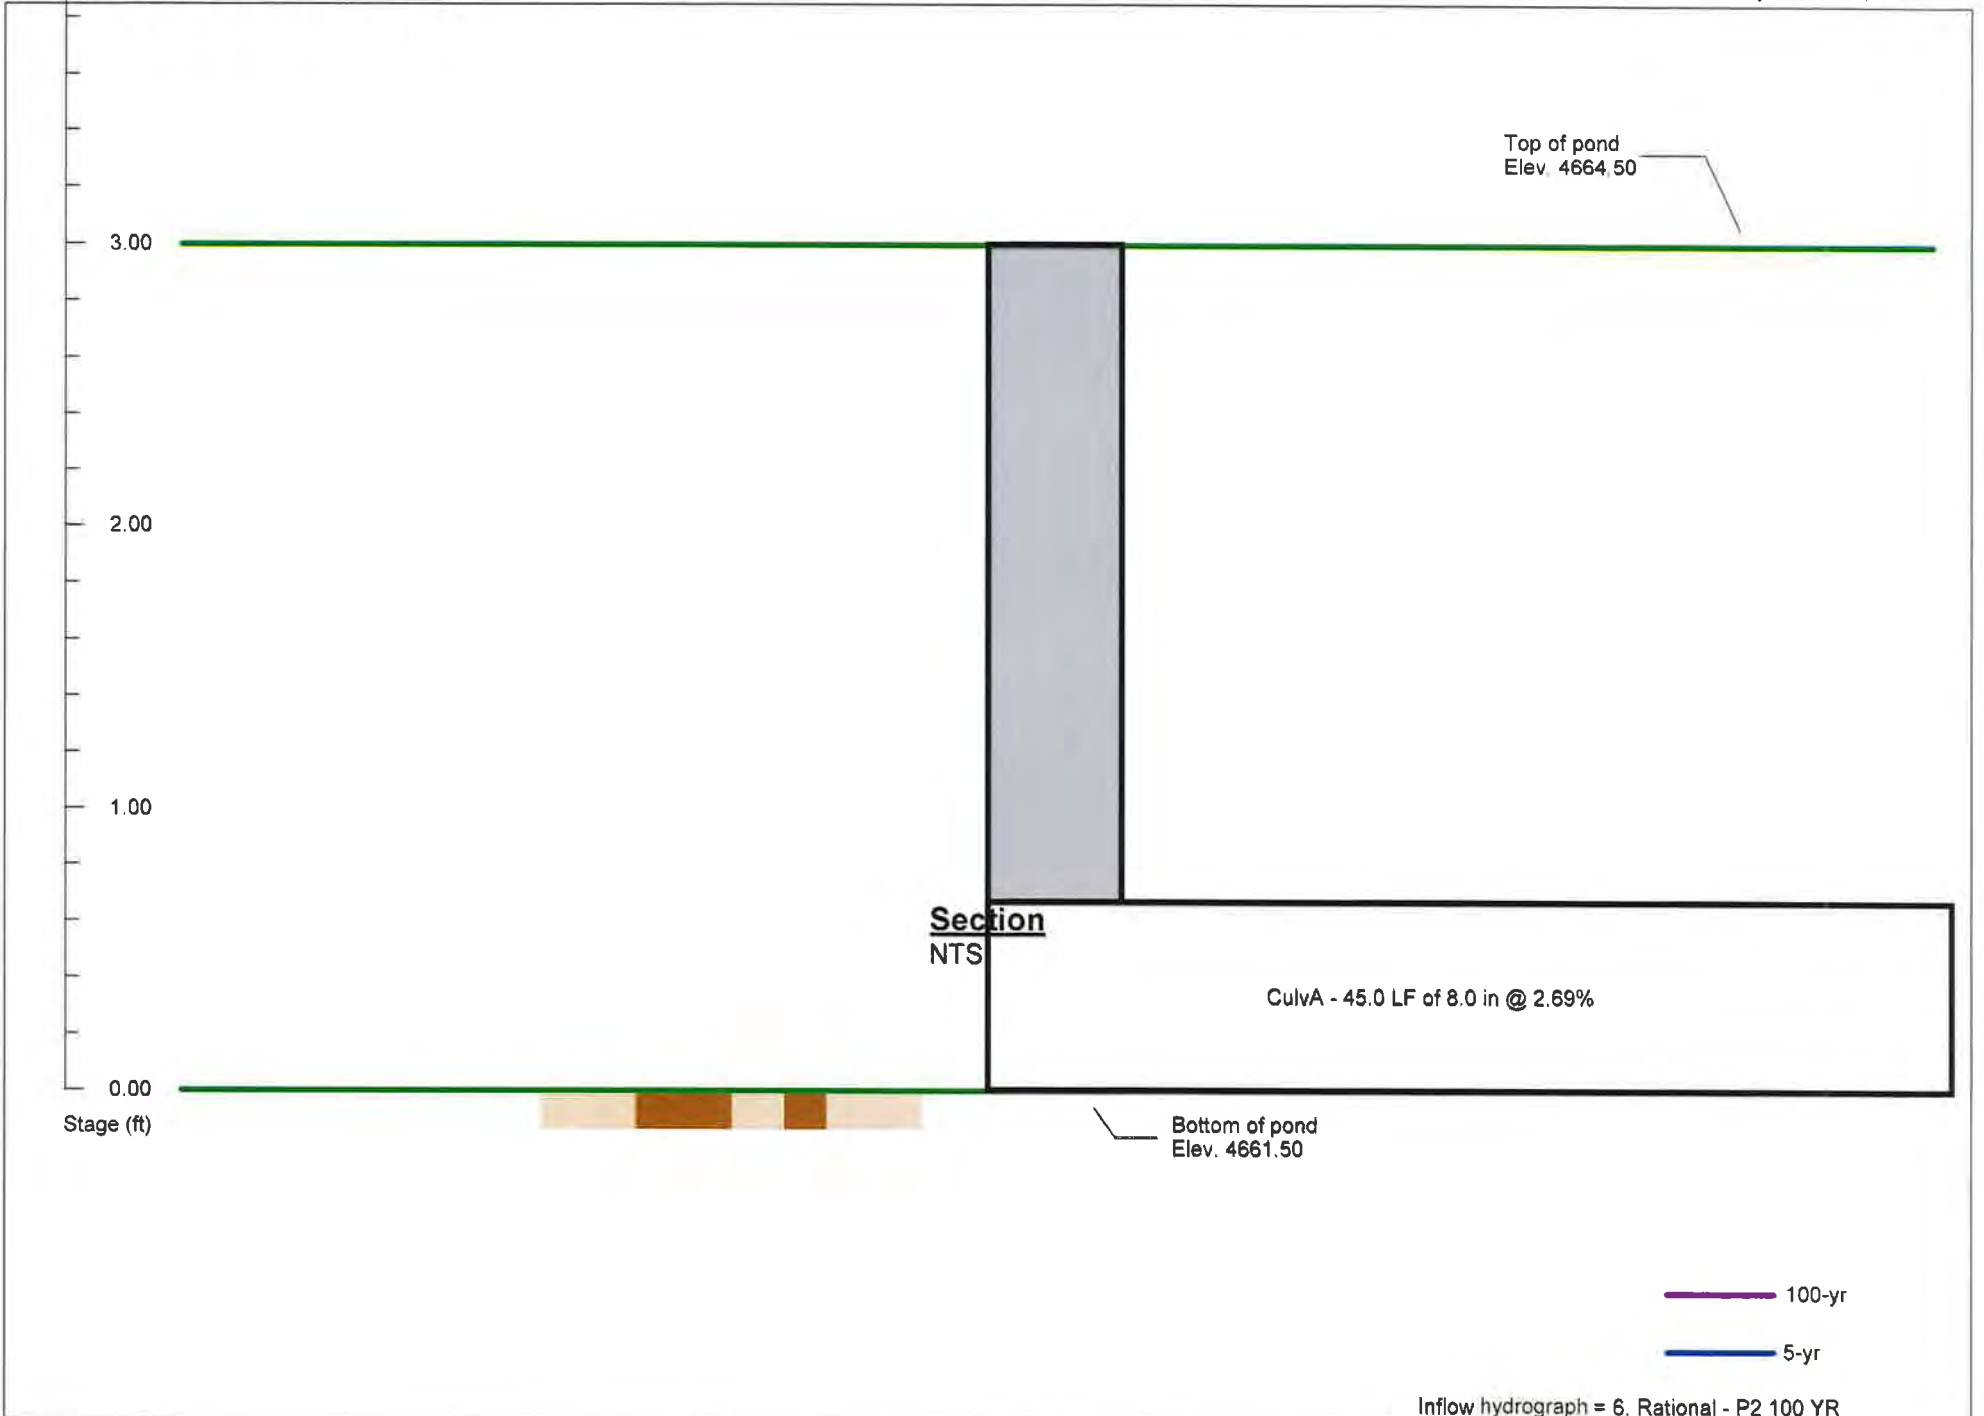
Pond⁰No. 1 - Pond 1

Inflow hydrograph = 6. Rational - P2 100 YR

Pond 1 - 100 YR Outflow

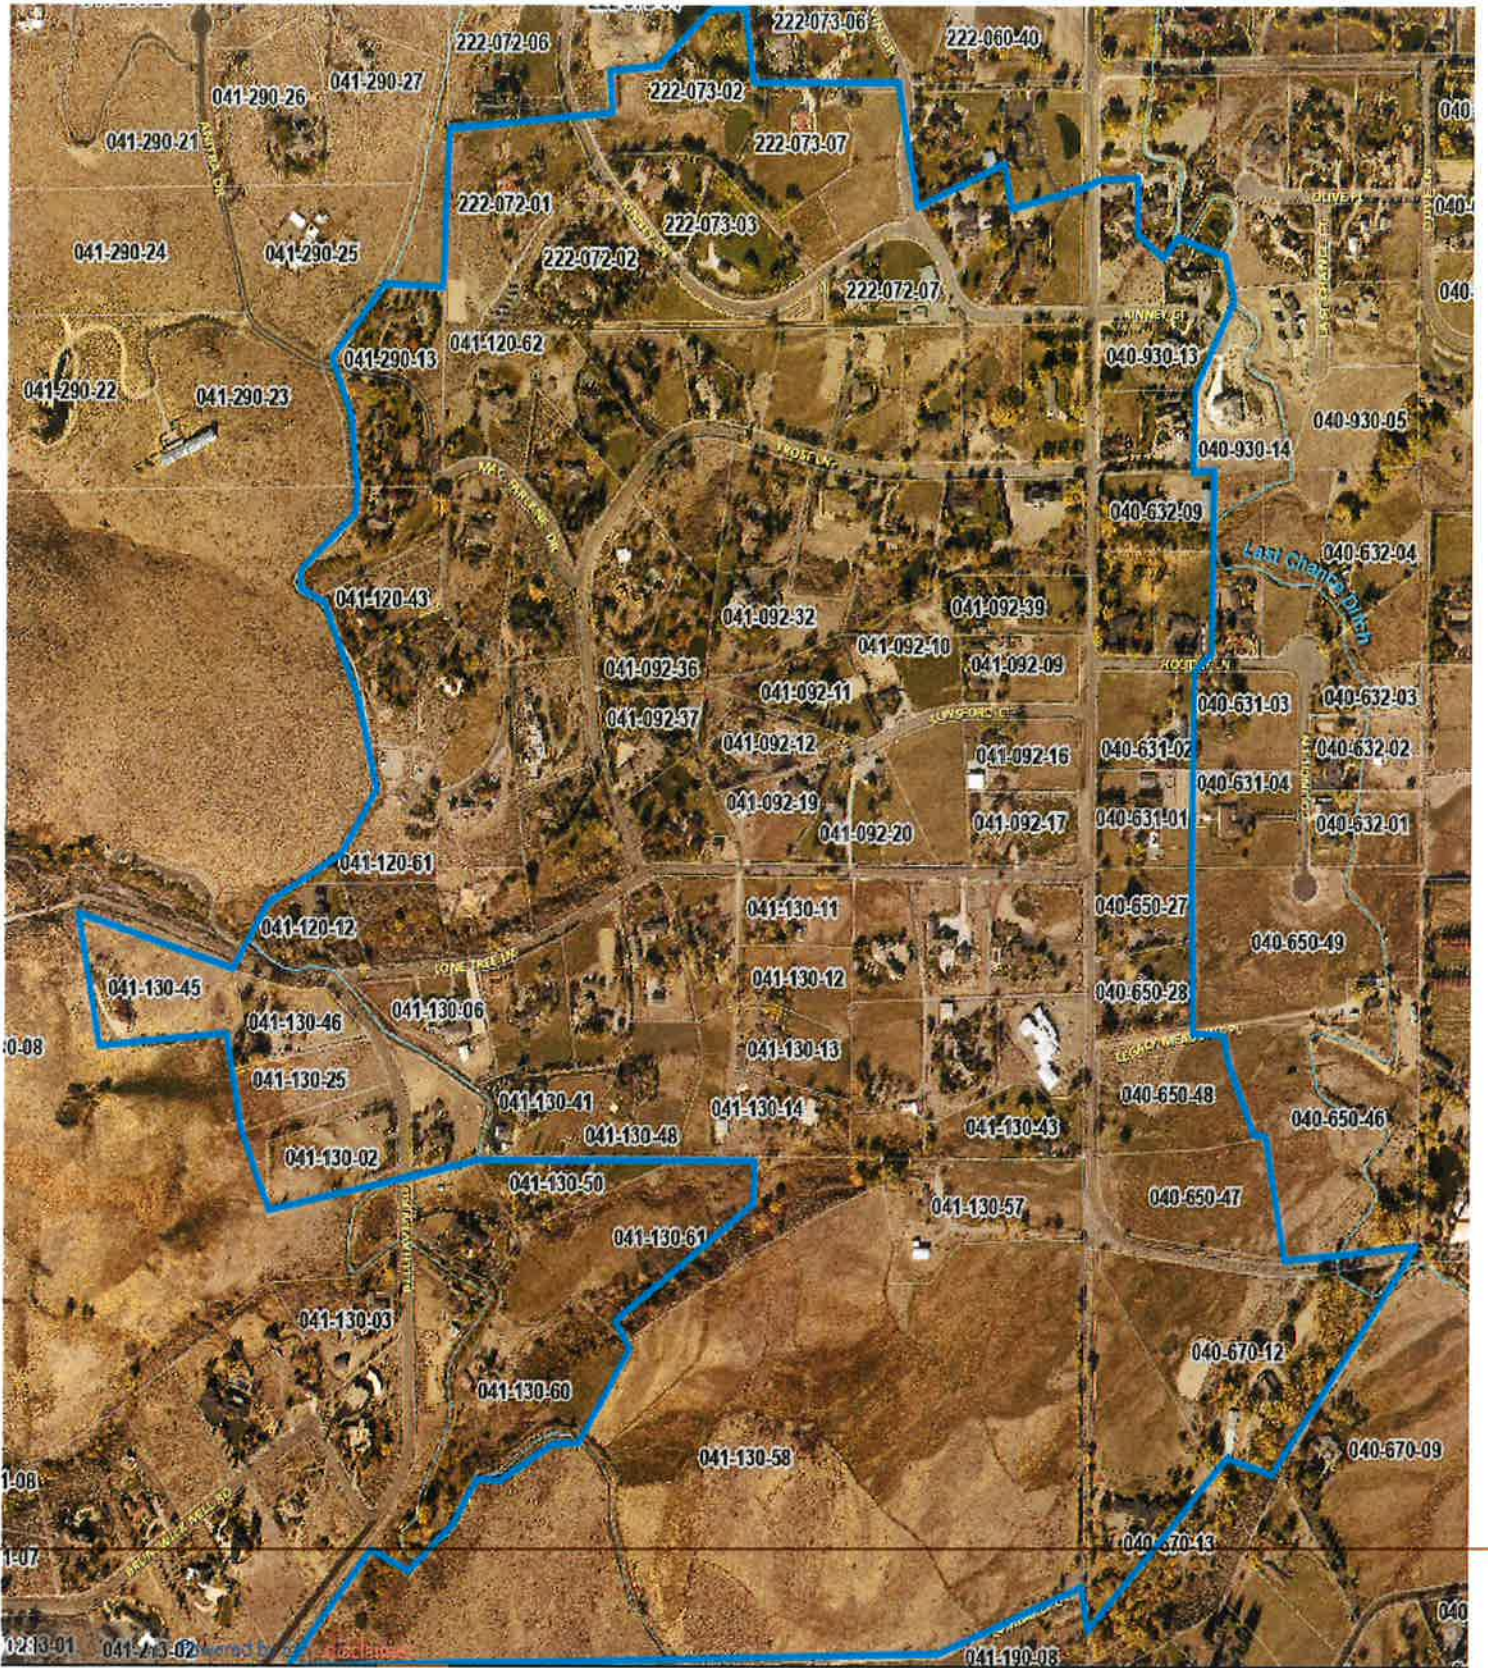
Map of contributing area. Taken from Washoe County GIS

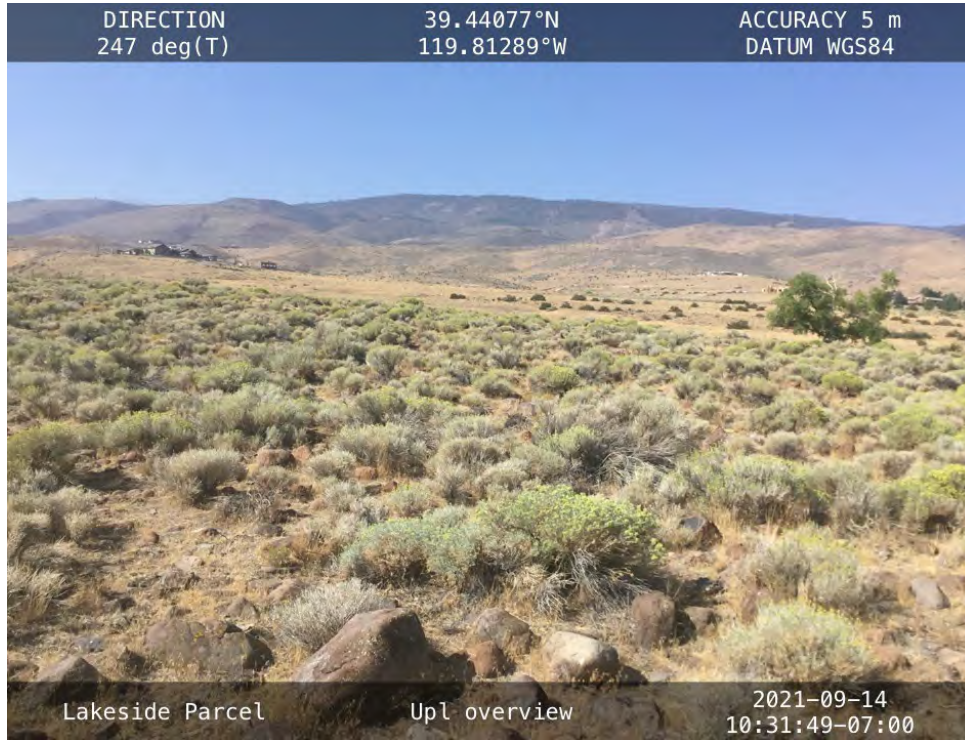
Line 2: Vs Model

(Photos 1 and 2 in Attachment C). Common grasses in these upland areas include meadow fescue (*Festuca pratensis*, UPL), slender wild rye (*Elymus trachycaulus*, FACU), and cheatgrass. Medusa head was observed in multiple areas throughout the Survey Area. Common forbs included whorled milkweed (*Asclepias verticillate*, FACU), Canada thistle (*Cirsium arvense*, FACU), and Curly-cup gumweed (*Grindelia squarrosa*, FACU). Black locust (*Robinia pseudoacacia*, FACU) and Western juniper (*Juniperus occidentalis*, UPL) are scattered throughout the Survey Area along the property boundaries, rocky areas and fence lines. Based on review of the soil types and unirrigated portions of the site, these areas suggest that the site would be naturally dominated by upland shrubs if left unirrigated.

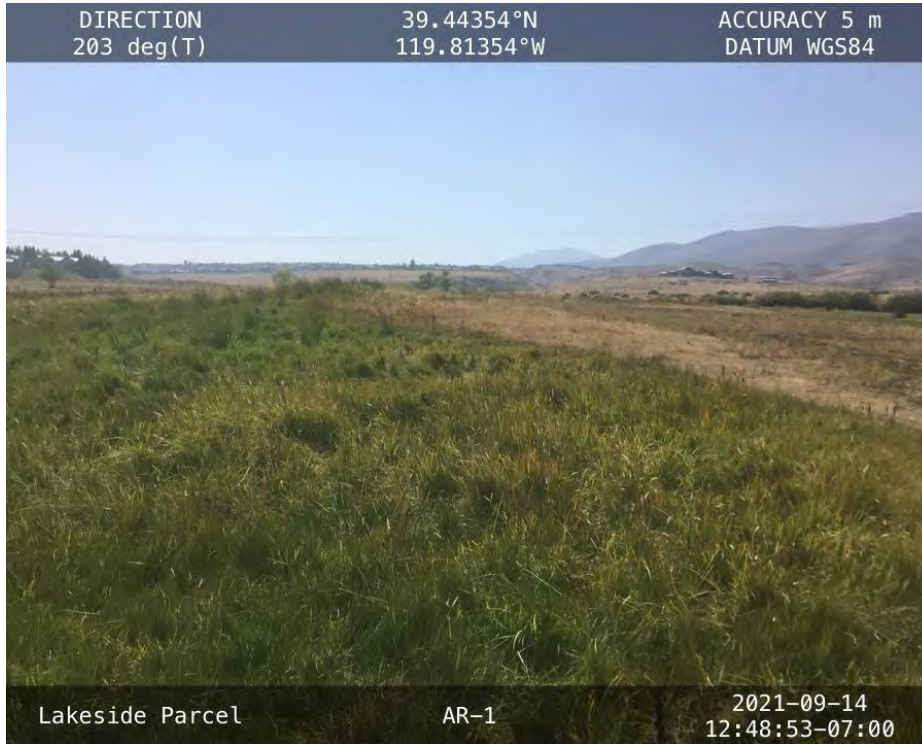
Photo 5. AR-1: PEM1C. Wetland boundary defined by distinct change in vegetation.

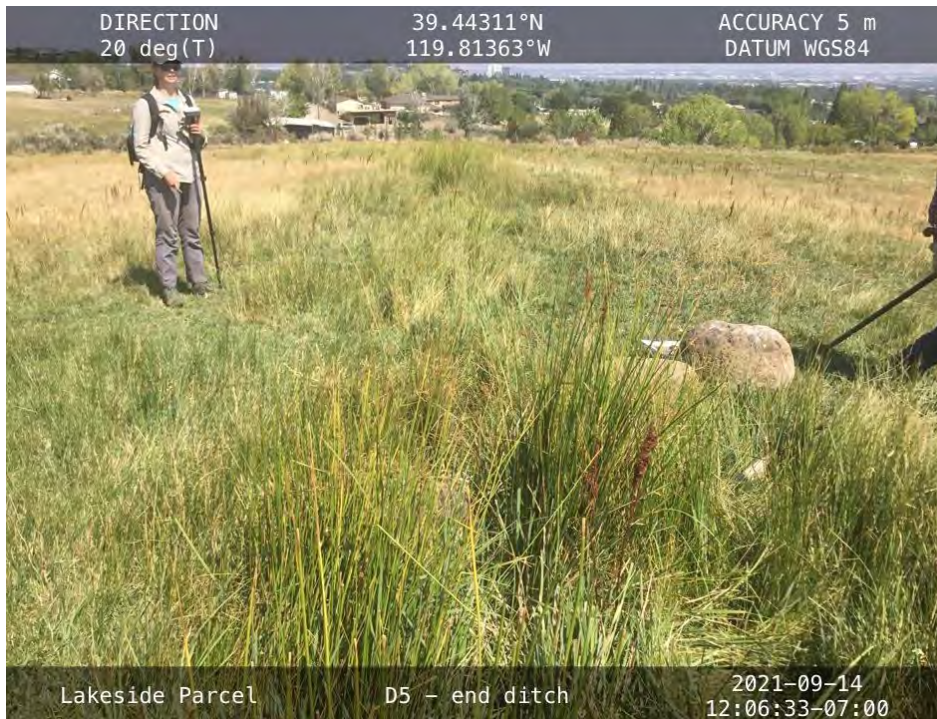
Photo 6. AR-1: PEM1C. End of D-5: Irrigation ditch at the start of AR-1.

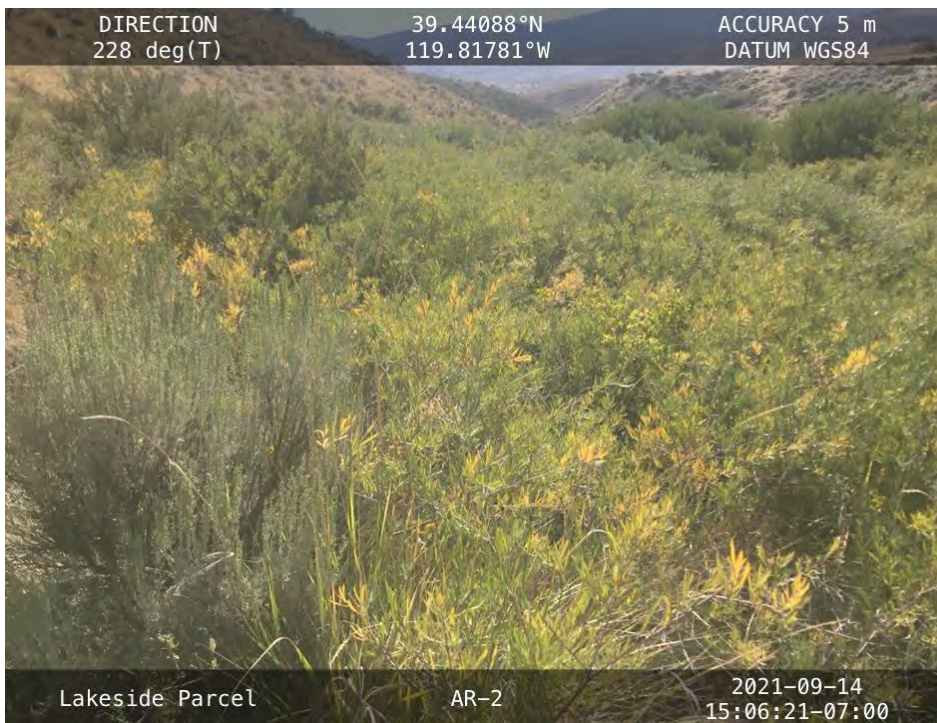
Photo 8. AR-2: PSS1C formed by seep at toe of slope. Wetland boundary delineated by distinct change in vegetation.

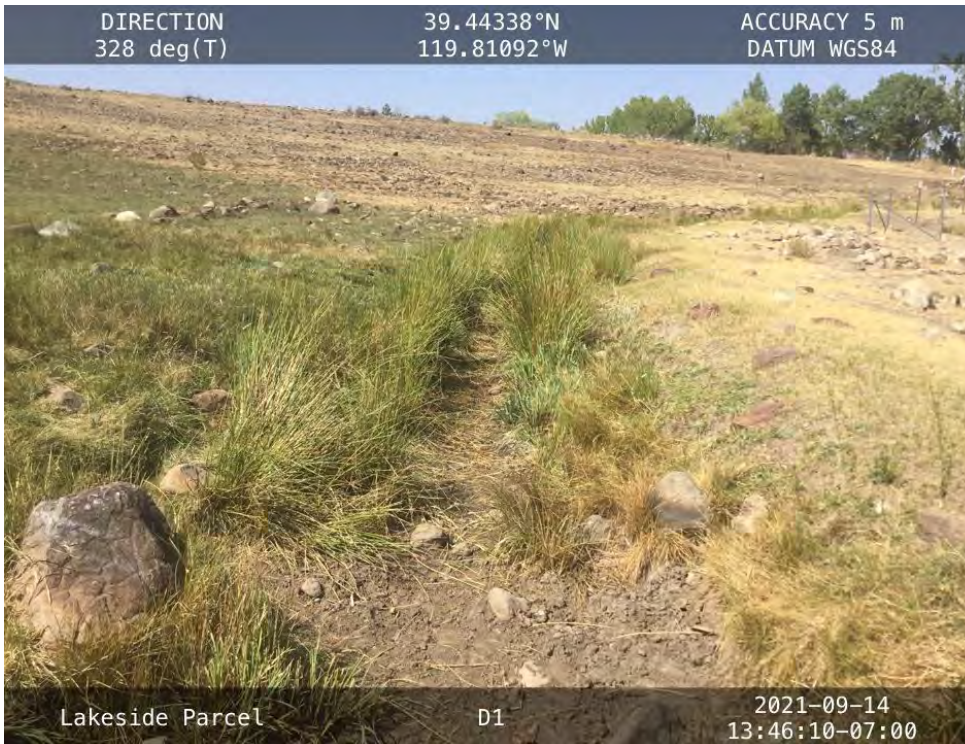
Supporting Literature

D-1: The on-site length of D-1 is 1,175 linear feet (0.05 acres). The width at the OHWM is 2 feet. D-1 is described in OHWM-1 data form in Attachment F and shown in photo 10 in Attachment C. D-1 is isolated and has no surface water connection to a TNW.

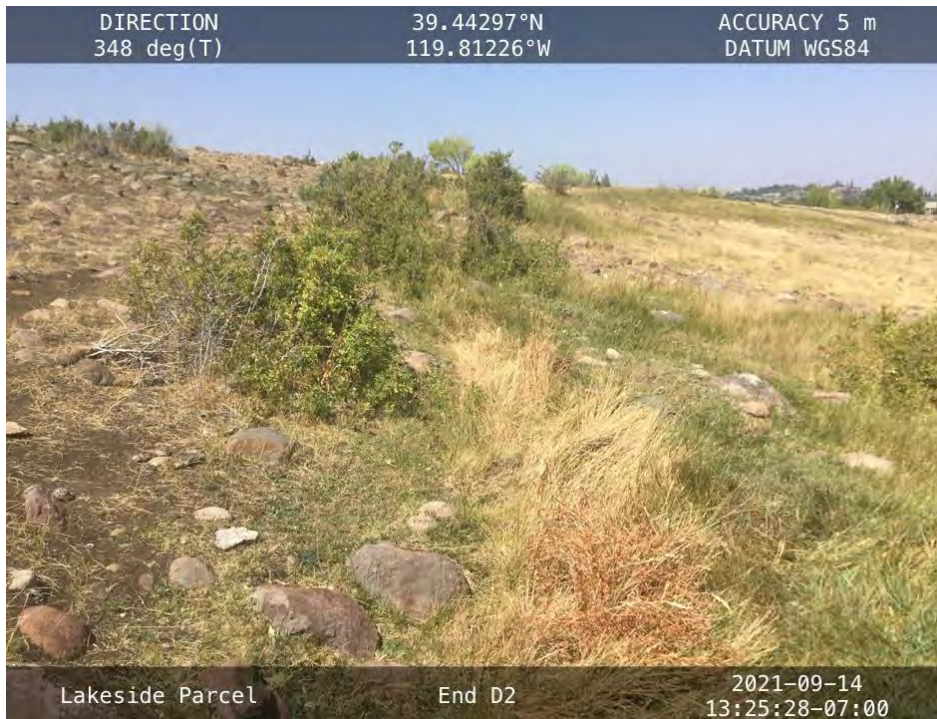
Photo 12. D-2 south end. Channel flattens in pasture and there is no longer a bed and bank.

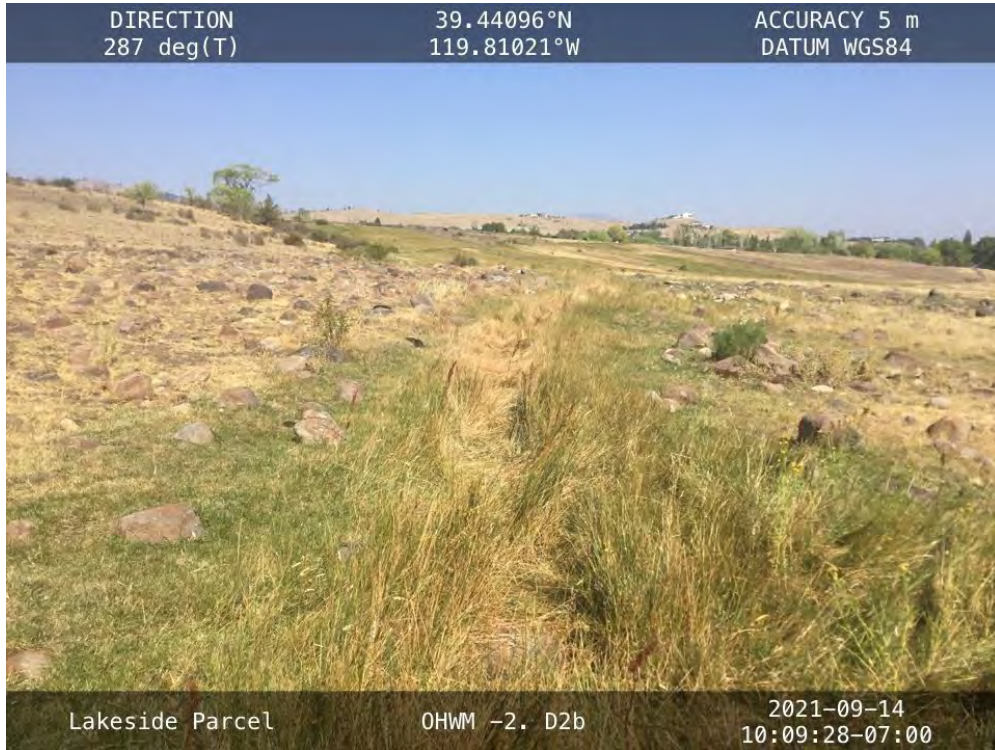
Photo 13. D-2b Ditch. Portions of ditch are fully vegetated, suggesting lack of recent flows.

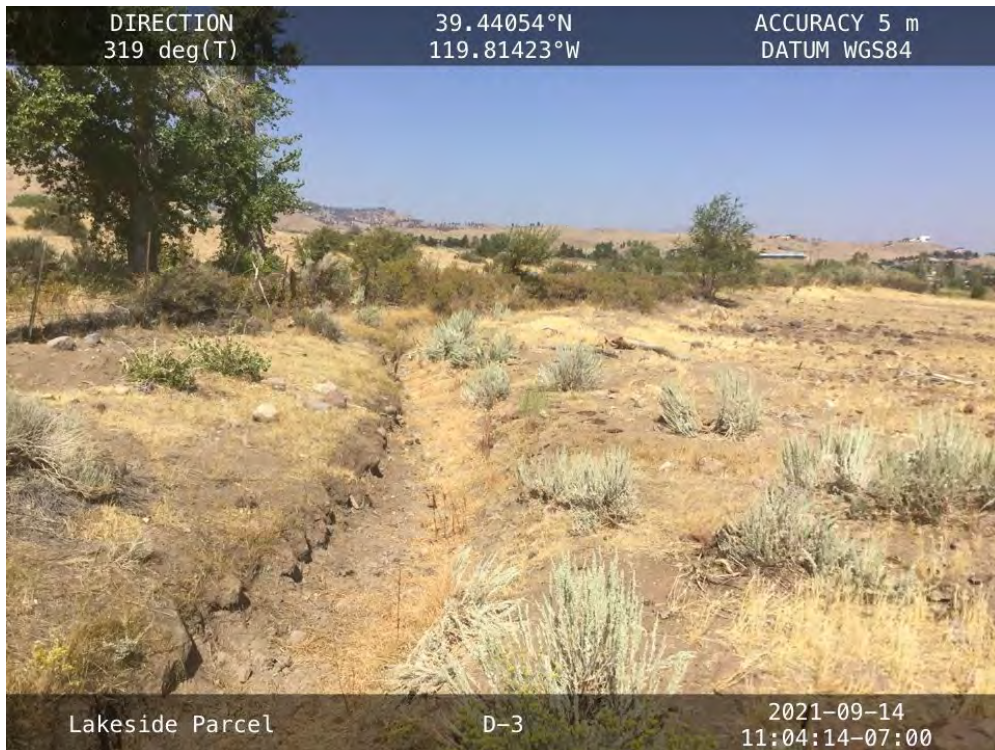
Preface

D-3 is a manmade, excavated irrigation ditch constructed through uplands. Water can be diverted from Steamboat Ditch (D-4) via a culvert and headgate before discharging into D-3; however, D-3 does not appear to have been recently used and portions of the ditch are vegetated with cheatgrass, an upland species. Ditch 3 meanders southeast through the parcel and dissipates along the hill slope (reference photo 15 in Attachment C). There is no surface water connection to a TNW.

The on-site length of D-3 is 1,193 linear feet (0.05 acres). The average width of D-3 is approximately two feet at the OHWM with a depth of six inches. The OHWM was identified in the field by a change in substrate. D-3 is described in OHWM-3 data form in Attachment F and shown in photos 14 and 15 in Attachment C.

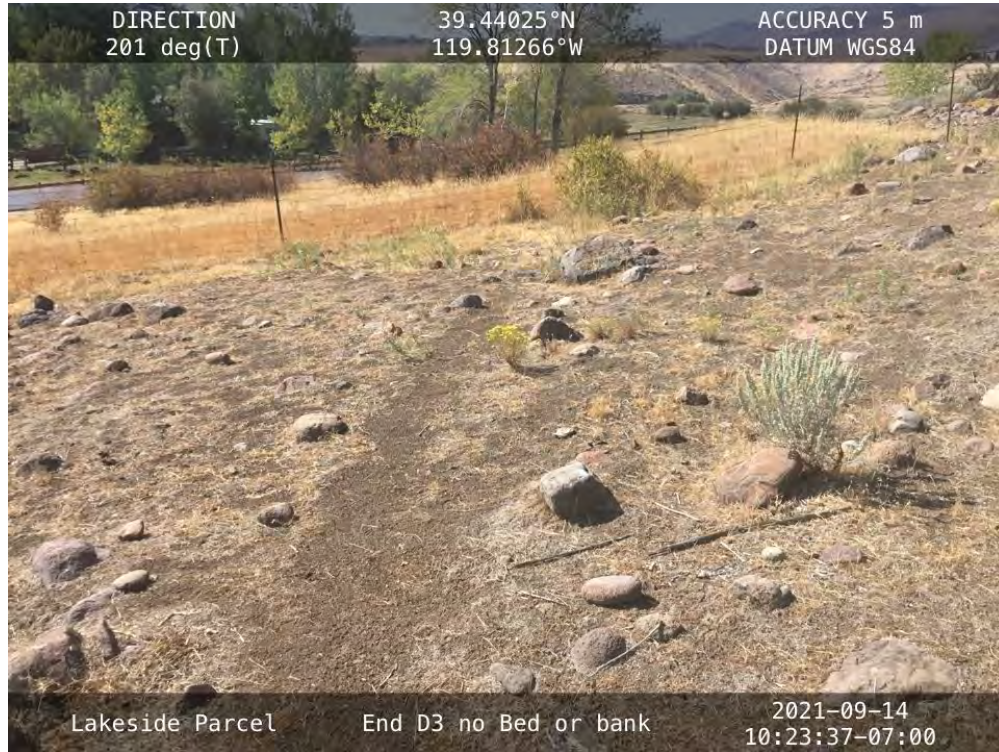
Photo 15. Southern end of D-3. Channel dissipates. No bed and bank or OHWM.
