8900 LAKESIDE CUSTOM LOT SUBDIVISION

SPECIAL
PACKETS
PACKAGE

TENTATIVE SUBDIVISION MAP APPLICATION – SPECIAL PACKET

GEOLOGIC AND SEISMIC HAZARDS REPORT
8900 LAKESIDE DRIVE PROPERTY
APN 041-130-58
RENO, WASHOE COUNTY, NEVADA

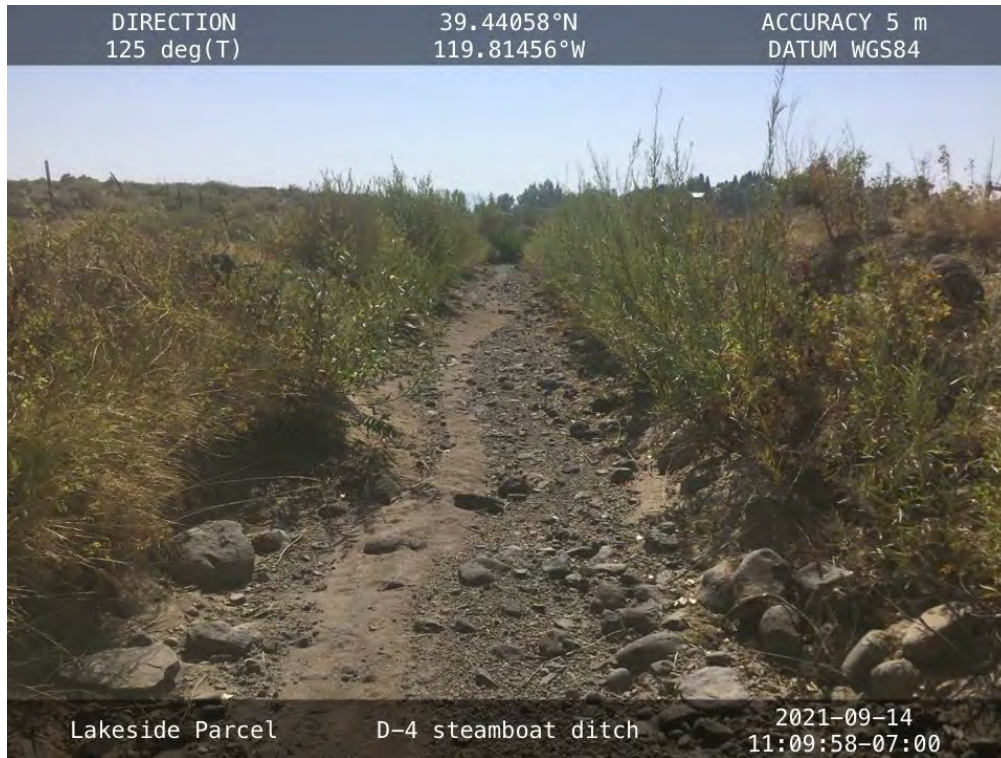
alternative means for communication of program information (Braille, large print, audiotape, etc.) should contact USDA's TARGET Center at (202) 720-2600 (voice and TDD). To file a complaint of discrimination, write to USDA, Director, Office of Civil Rights, 1400 Independence Avenue, S.W., Washington, D.C. 20250-9410 or call (800) 795-3272 (voice) or (202) 720-6382 (TDD). USDA is an equal opportunity provider and employer.

The on-site length of D-4 is 900 linear feet (0.26 acres). The average width of D-4 is approximately 13 feet at the OHWM. Depth at the OHWM is two feet. The OHWM was identified in the field by an undercut bank, scour, and lack of vegetation. D-4 is described in OHWM-5 data form in Attachment F and shown in photo 17 in Attachment C.

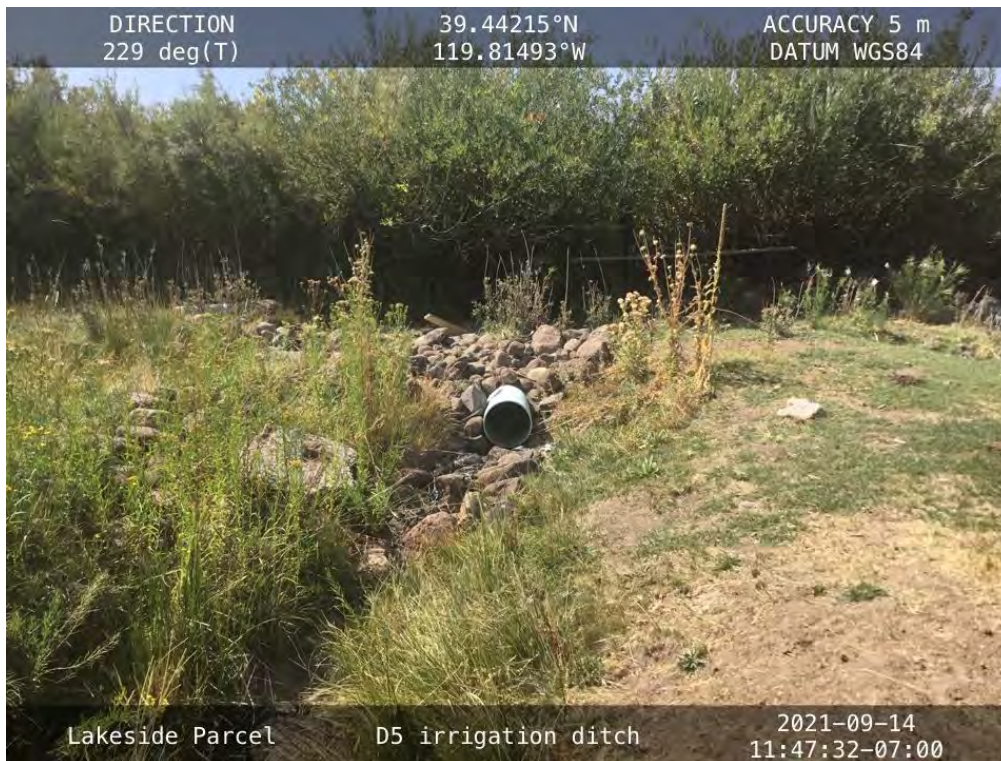
Photo 18. D-5: Irrigation ditch. Water from D-4 is discharged via a culvert under access road into D-5

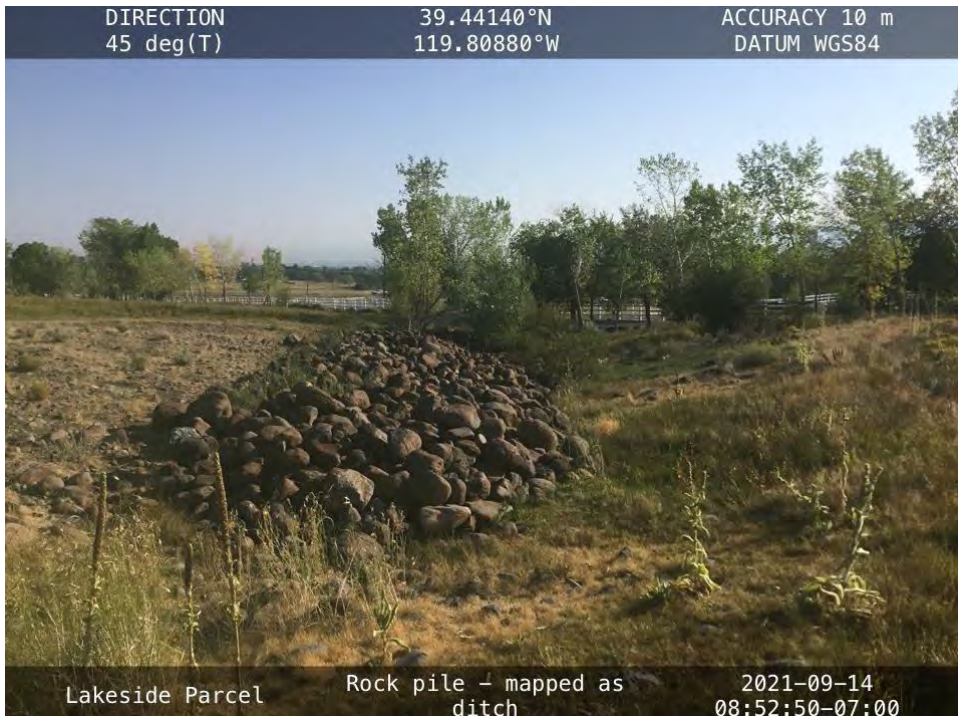
Photo 24. Swale mapped as "riverine" on NWI map. D-1 out flows to this rock lined swale.

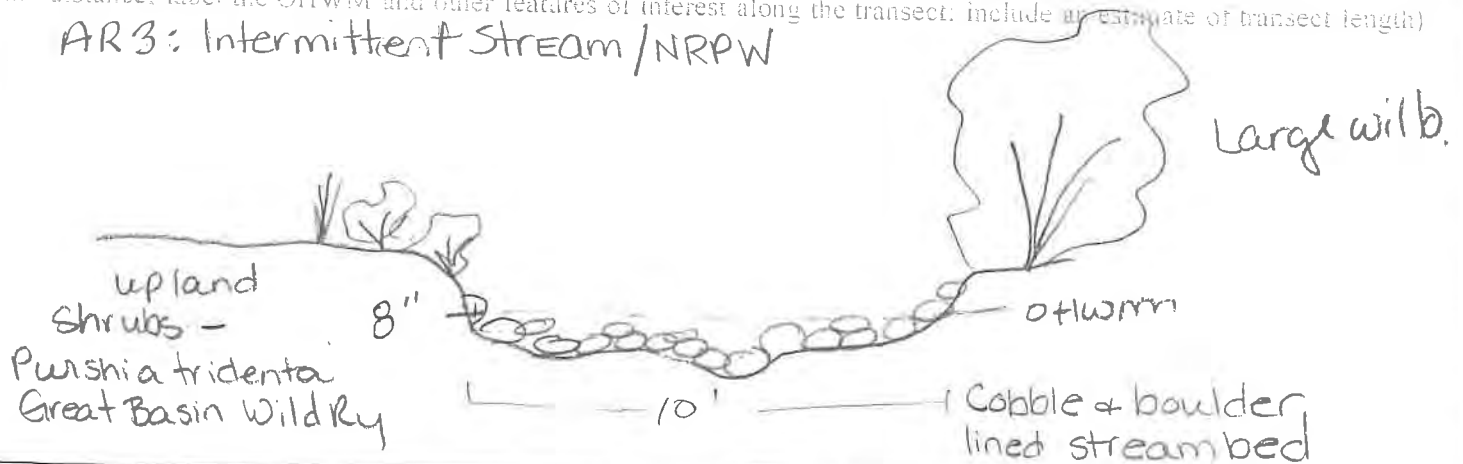
AR 3: Intermittent Stream / NRPW

Transect (cross-section) drawing: (Choose a location that is representative of the dominant stream characteristics over some distance; label the OHWM and other features of interest along the transect; include an estimate of transect length)

Total on-site length of AR-3 is 565 linear feet (0.13 acres). The width of AR-3 at the OHWM is approximately 10 feet. Depth at the OHWM is 8 inches. The OHWM was identified in the field by change in substrate, rack lines and sediment debris. AR-3 is described in OHWM-8 data form in Attachment F and shown in photo 9 in Attachment C.
