To: Washoe County – Community Services Department
From: Keith Anderson – Flood Defense Group
Date: 13 June 2019
RE: Review of installed HESCO Bastion Barrier Protection Systems

This is a report that summarizes my review of the HESCO Bastion flood defenses around Swan Lake in Washoe County, NV.

Design and Construction Washoe County HESCO Bastion

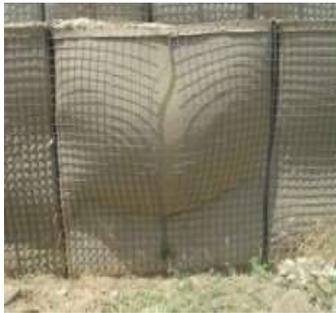
Step 1

Step 1: Identify the unit to be fixed

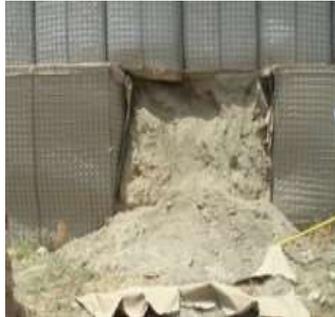
Step 2

Step 2: Cut out damaged material and remove any soil that spills out such that a new panel can be freely attached without obstruction from the dirt. *NOTE: If the wire of the damaged unit is not significantly damaged, it can often be left in place and the repair panel simply overlaps the damaged panel*

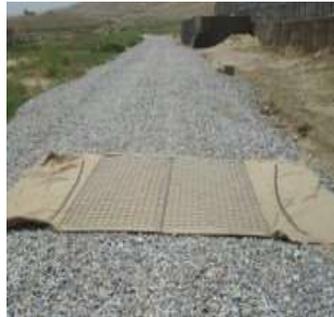
Step 3

Step 3: Prepare a single panel of the same size as the one being repaired by taking a single panel with extra fabric on each side and a coil which is attached or 'screwed on' to each side of the panel

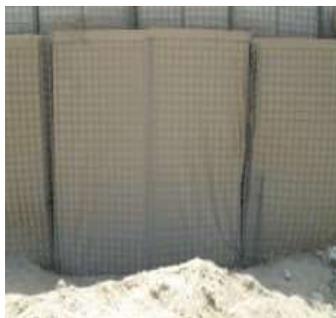
Step 4

Step 4: Attach the replacement panel (or panels) to the unit being repaired using coils and pins provided to create a join and ensure the extra fabric lines into the newly repaired basket to ensure a tight 'seal' from leakage of the fill material.

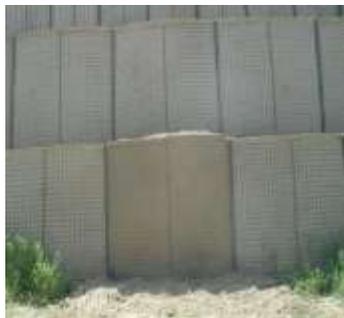
Step 5

Step 5: Backfill and top off repaired cell with fill material.

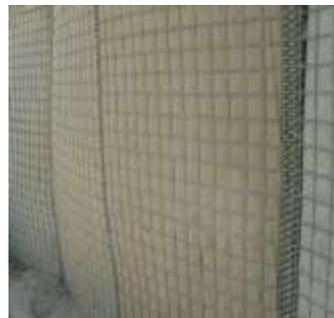
Finished View

Finished View: In this example, multiple coils were screwed together in creating this join as discussed during the inspection.

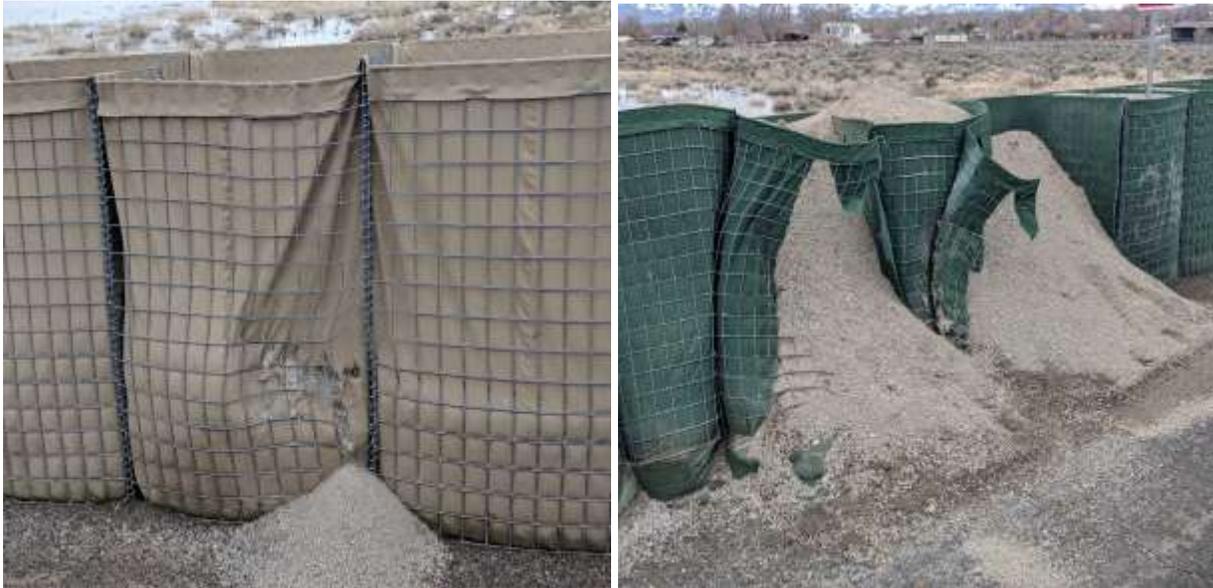
Notes: I viewed common damage associated with a vehicle impact. Repair as detailed above. The green units will require multiple panels and a pair of bolt cutters to cut the panels to fit the now deformed units.

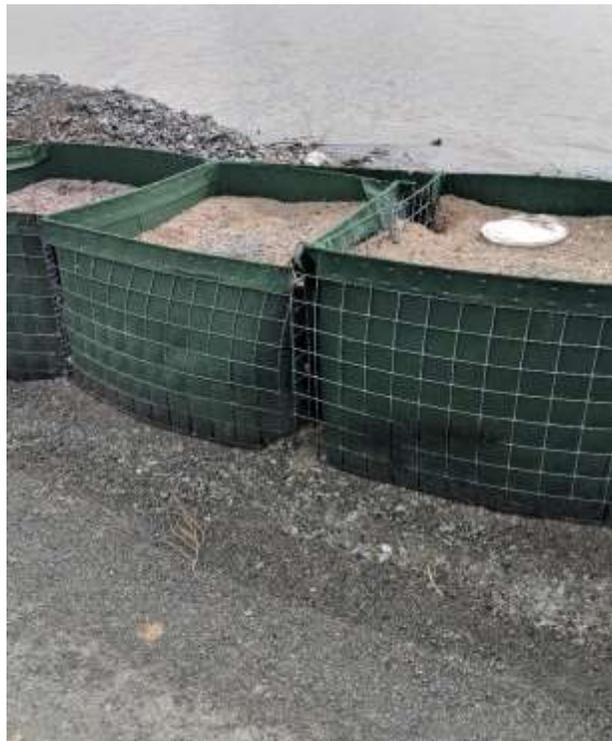
Notes: This is on the 'dry side' of the barrier and it would still function but I suggest you insert a coil to create a correct connection of the welded wire panels. Because the units are full, it may take a couple coils to tie it together.

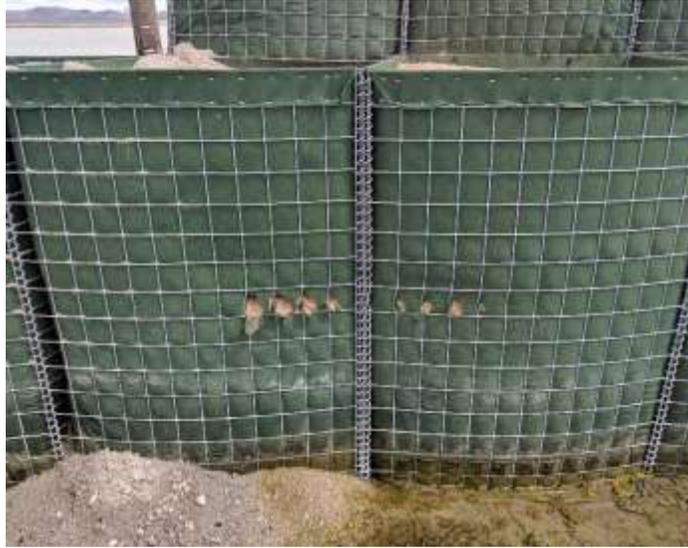
Notes: This is common form of damage where a vehicle or some sort of equipment 'side swipes' the HESCO Bastion and is generally not a huge issue. This can be repaired by overlapping another panel without even removing the damaged panel or by spraying/spackling a cement mixture over the holes.

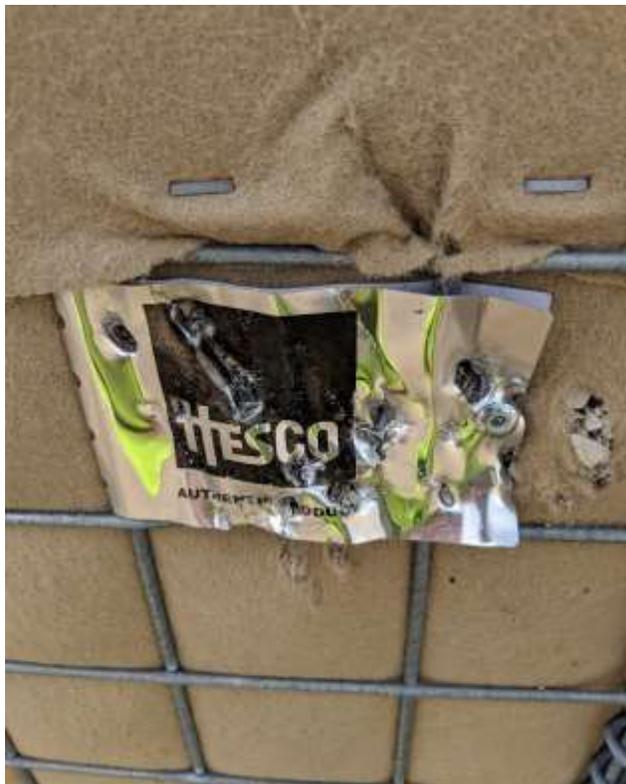
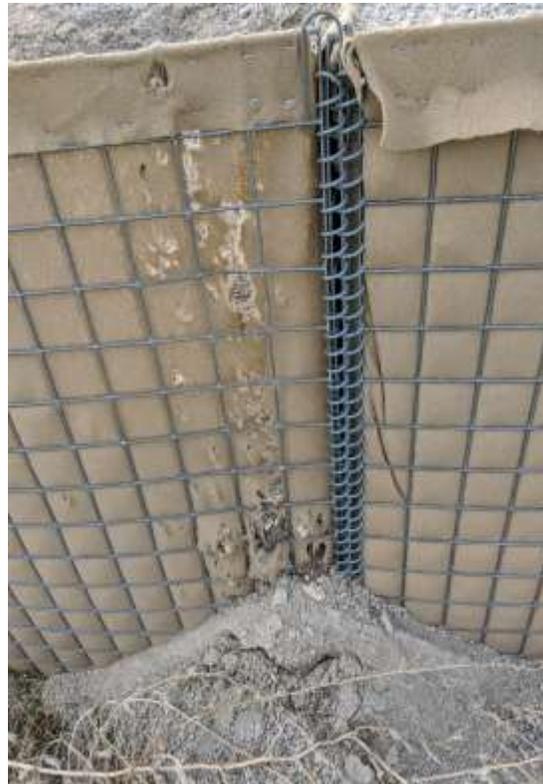
Notes: These are examples of what I believe to be vandalism and a great reason for using HESCO Bastion. They are difficult to compromise through vandalism as it would require actual work to do it. In this case, someone appears to have been repeatedly stabbing the units with something similar to a screwdriver. In some cases where a local municipality is installing flood defense barriers and there are members of the public who are opposed to it, vandalism is not uncommon.

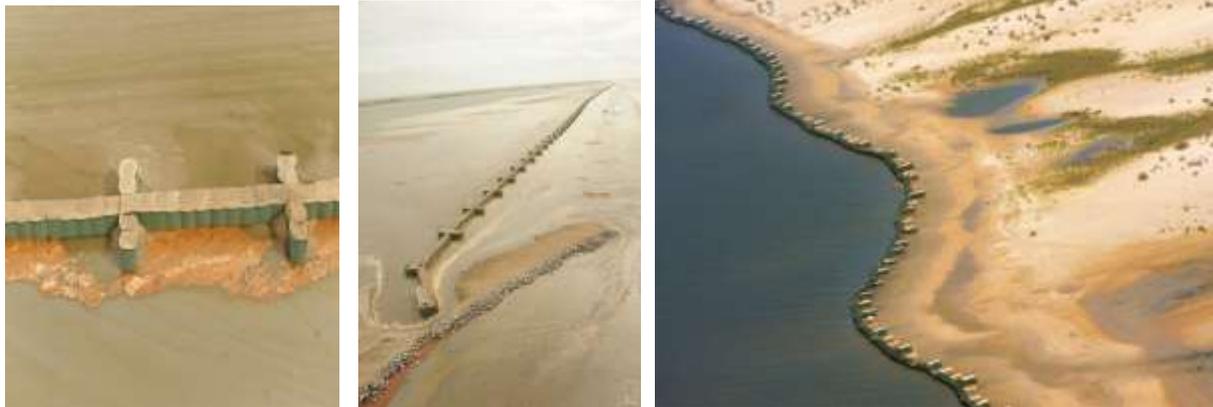
Examples of using additional cells to 'buttress' and/or 'anchor' a line of HESCO Bastion are below

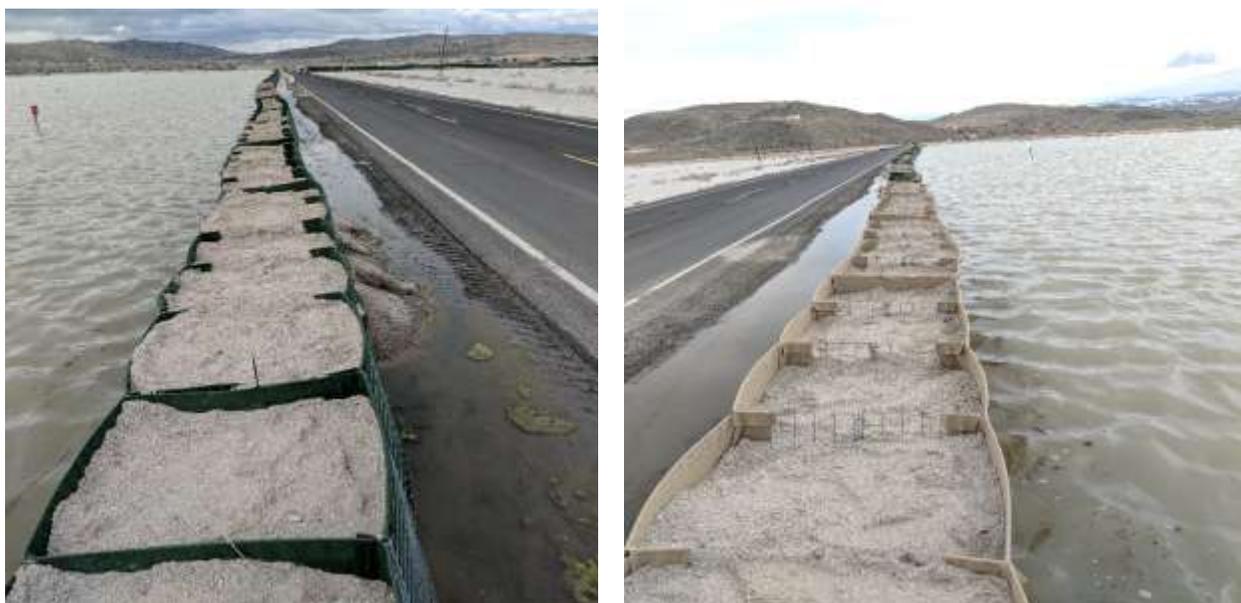
You have a section of HESCO Bastion along the road which is leaning toward the water and steps should be taken to reinforce this section from further leaning. I would take the following steps to reinforce this area.

Below is the leaning section at Swan Lake. It is not a disaster but can be reinforced as pictured above.

- 1) Prepare a 2 cell section of HESCO Bastion
- 2) Butt it up to the leaning section on the wet side of the barrier and attempt to get at least a partial connection using the coils and pins provided
- 3) Fill
- 4) Repeat this process every 7-10 cells along your wall as desired along the leaning section

NOTE: This process could be also done on the dry side of the barrier instead, or in addition, to 'Anchor' this section from leaning toward the water. I believe there are footprint restrictions which may make this option unfeasible.

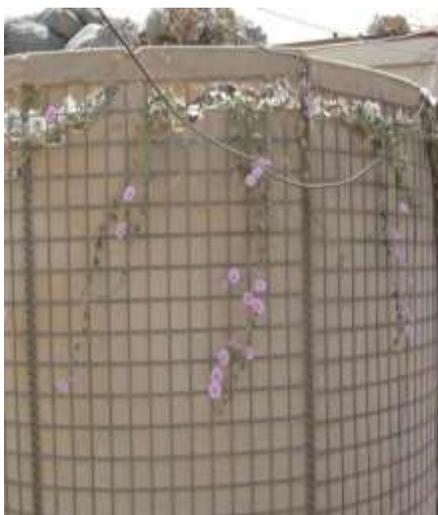
Picture: Stress Tears – Initial Degradation

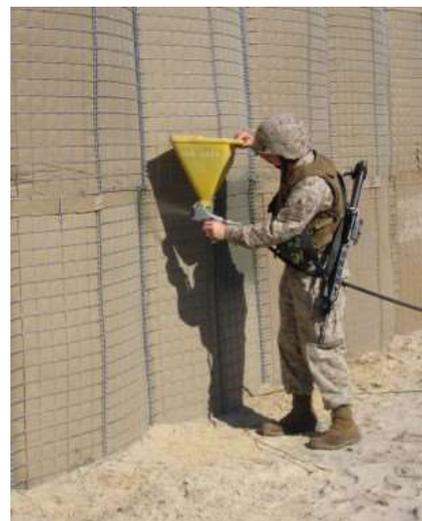
Picture: Cement Slurry for UV protection

If your HESCO Bastion units are expected to be in place for longer than 5-7 years, they can be painted or a cement slurry application similar to stucco can be applied to protect the geotextile from the sun. In doing this, the product life span moves from the 5-7 year life of the geotextile to the 25 year design life of the wire which this product is comprised of.

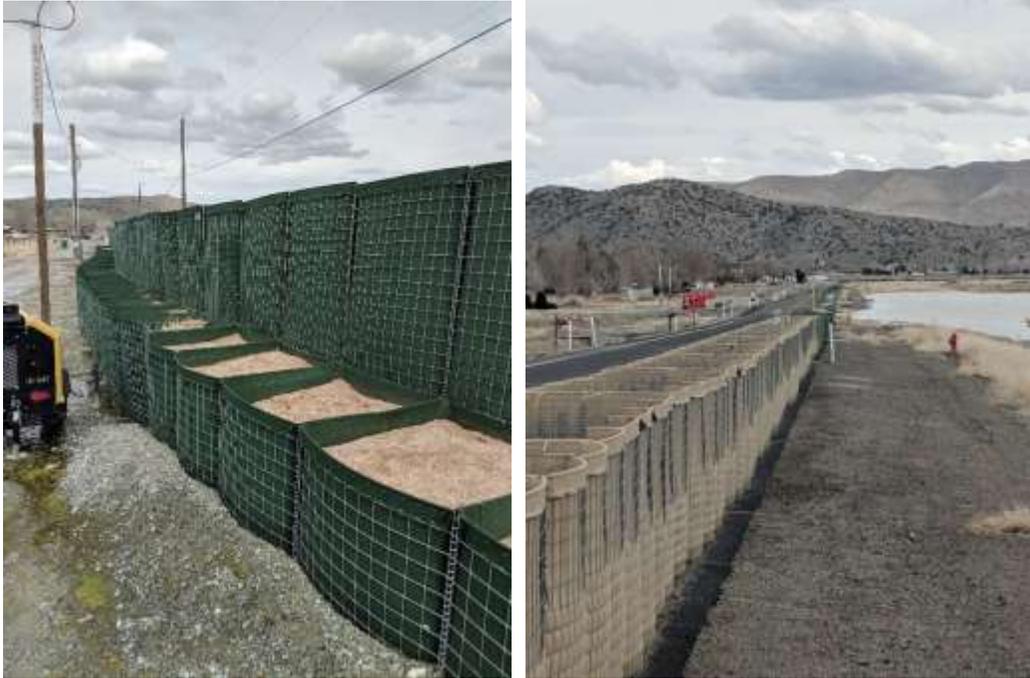
NOTES: The GREEN units pictured are stacked and connected well. They would function as designed in their current state but the added fill simply extends the lifespan of the units. As mentioned above, the fill level of the BROWN units would do well at stopping water to the height of the fill material and would be easier to remove than full units but if you leave these in place, topping them off with fill material would be advised.

However, in the case of Washoe County, these units are left in place for what could be over a few years. If this is the case, filling the units completely is suggested and will extend the lifespan of HESCO Bastion

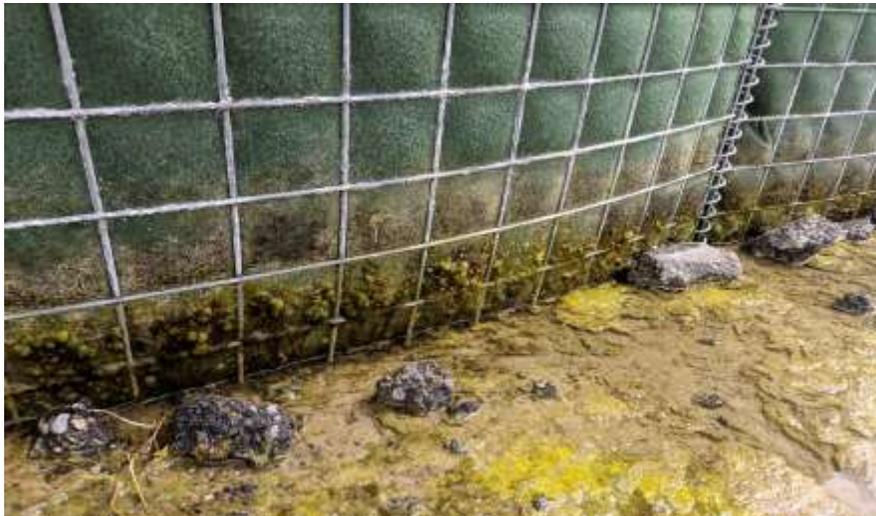
Notes: Moss is not a problem and does not cause any sort of accelerated degradation of the HESCO Bastion geotextile. It actually provides a barrier against UV rays and seems to be more beneficial than harmful.

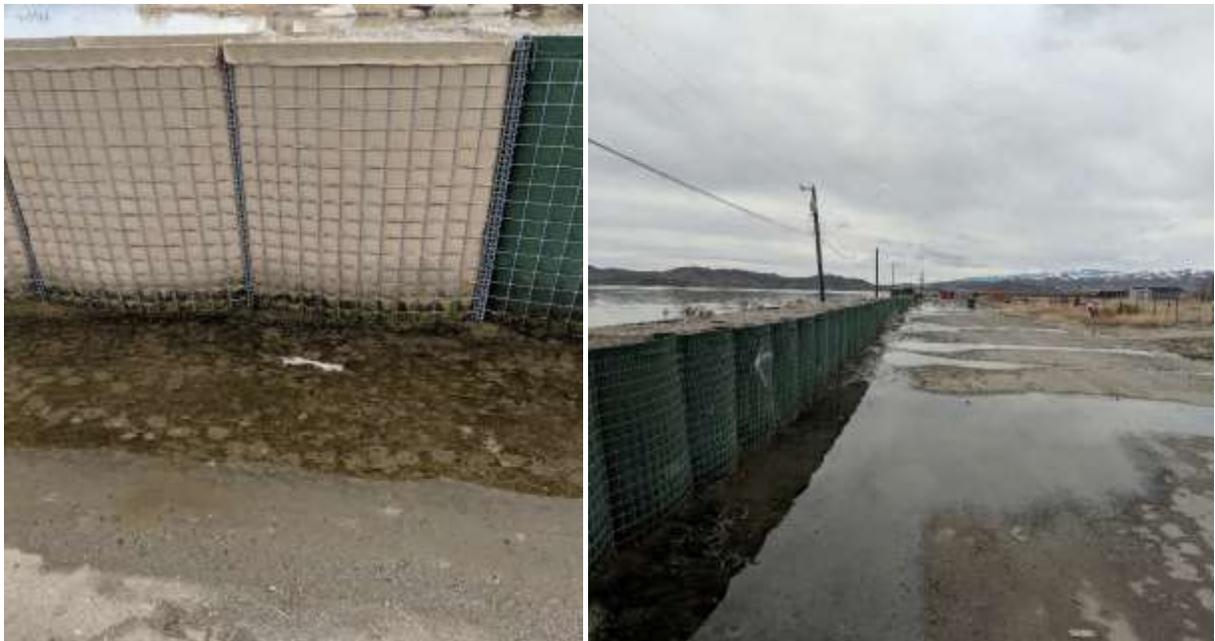
We are normally proponents of plastic as it is an inexpensive line of defense against seepage. In your case, I am not sure that you will need it as you have pumping capability and plenty of standoff from structures being protected. I believe you could easily keep up with any seepage and would enjoy avoiding the logistical burden of installing and maintaining a liner of plastic sheeting that quickly degrades in the sun. I assume you also experience a lot of wind which can create additional challenges with plastic sheeting. (However, you may find plastic sheeting helpful for seepage under any water tubes installed)

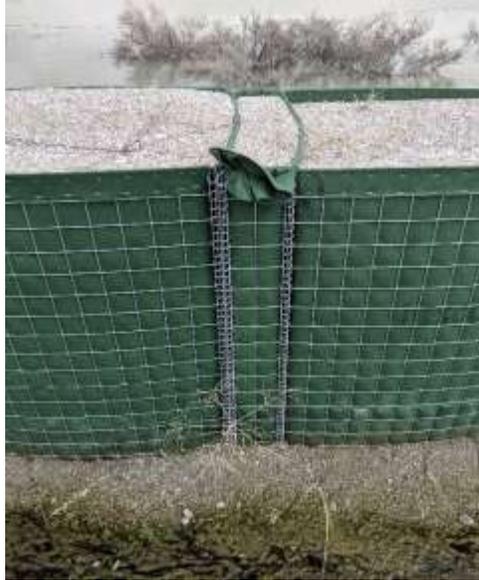
NOTE: This is likely were two sections came together and they took the time to modify a unit and create a good connection which was then correctly lined with geotextile.

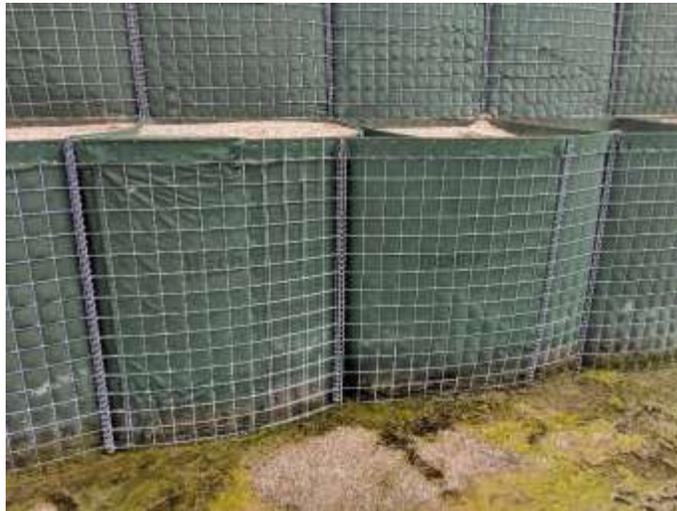
NOTE: It looks like someone missed inserting a joining pin during the initial layout and the units were filled. Someone in your staff identified this and overlapped it with two face panels AND figured out the lesser-known technique of screwing the coil to the weldmesh itself to create a fantastic fix. I really appreciate the attention to detail in taking the time to fix it!

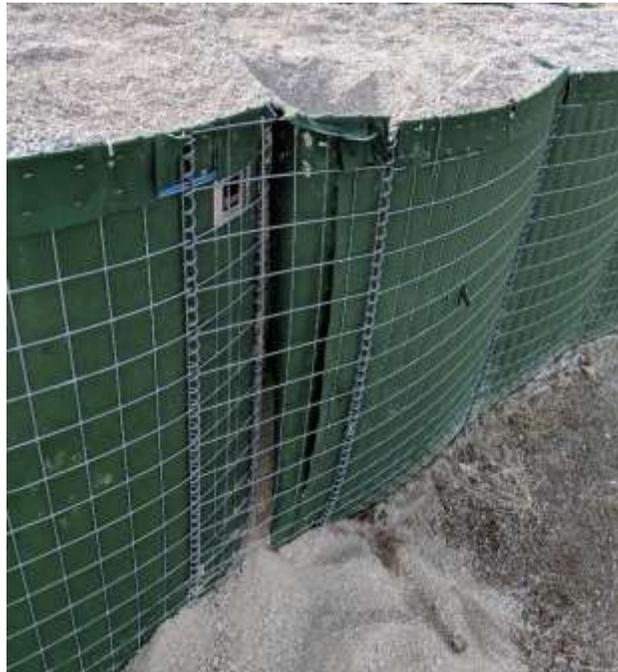
Notes: Similar to the photo above, good fix!

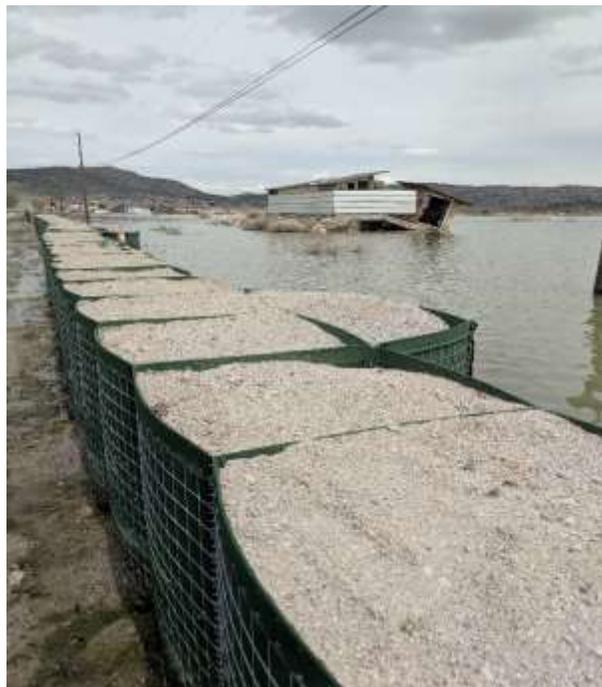
Note: Someone within your staff created a buttress wall similar to what you require for your leaning section of HESCO Bastion. This person will be well suited to do the repair of your leaning units. This crew did well at taking note to create the best connections possible which is great to see.

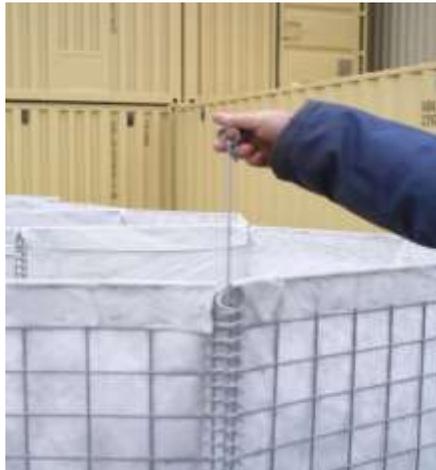
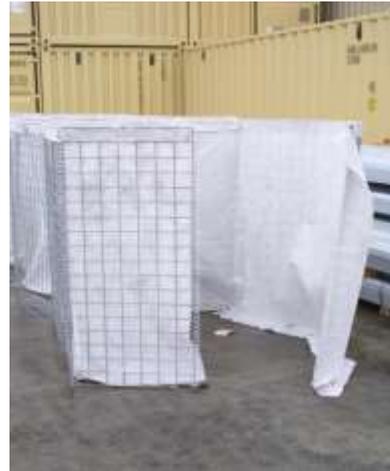
Below: HESCO Bastion Recoverable Unit

You have two different types of HESCO Bastion. One type is recoverable which is done by pulling the joining pins found running down the spine of the HESCO Bastion and simply peeling each side of the HESCO Bastion away from the dirt. Photos of this product are below.
