Washoe County

November 16, 2022

Re: Concurrence on a Finding of "No Historic Properties affected" for Phases 3 and 4 of the Nevada Cares Campus Project

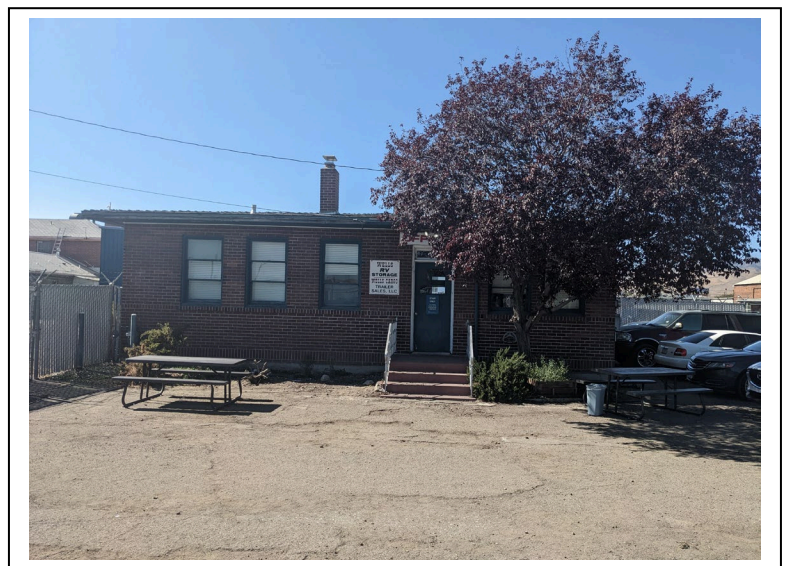
Construction Date	1943	
Architectural Style	No style	
Architectural Type	Industrial office	
Roof Form	Pyramid	
Roof Materials	Composition shingles	
Exterior Wall Materials	Brick	
Foundation Materials	Concrete	
Window Materials	Wood	
Window Type	Triple hung	
Accessory Resources?	Yes <input type="checkbox"/>	No <input checked="" type="checkbox"/>
	Number?:

Condition of Resource(s)?		
Good <input checked="" type="checkbox"/>	Fair <input type="checkbox"/>	Poor <input type="checkbox"/>
Explanation: The building has received few modifications and retains most original features both internally and externally.

B15585 is a small square timber frame brick clad office building with a pyramidal roof, a concrete foundation, and a full basement. The walls of the building face the cardinal directions. The building is located on the west side of Threlkel Street, in the southeast corner of the original part of the Wells Cargo Freight Yard. The position of the office suggests that one of its functions was monitoring and tracking vehicles moving into and out of the freight yard. According to the Washoe County Assessor, the building was constructed in 1946, and is visible in an aerial photograph dated to that year. Nova Geotechnical & Inspection Services recently produced a Phase 1 Environmental Site Assessment report of the site and identified B15585 as having been constructed in 1943 (Nova Geotechnical & Inspection Services 2020:16).

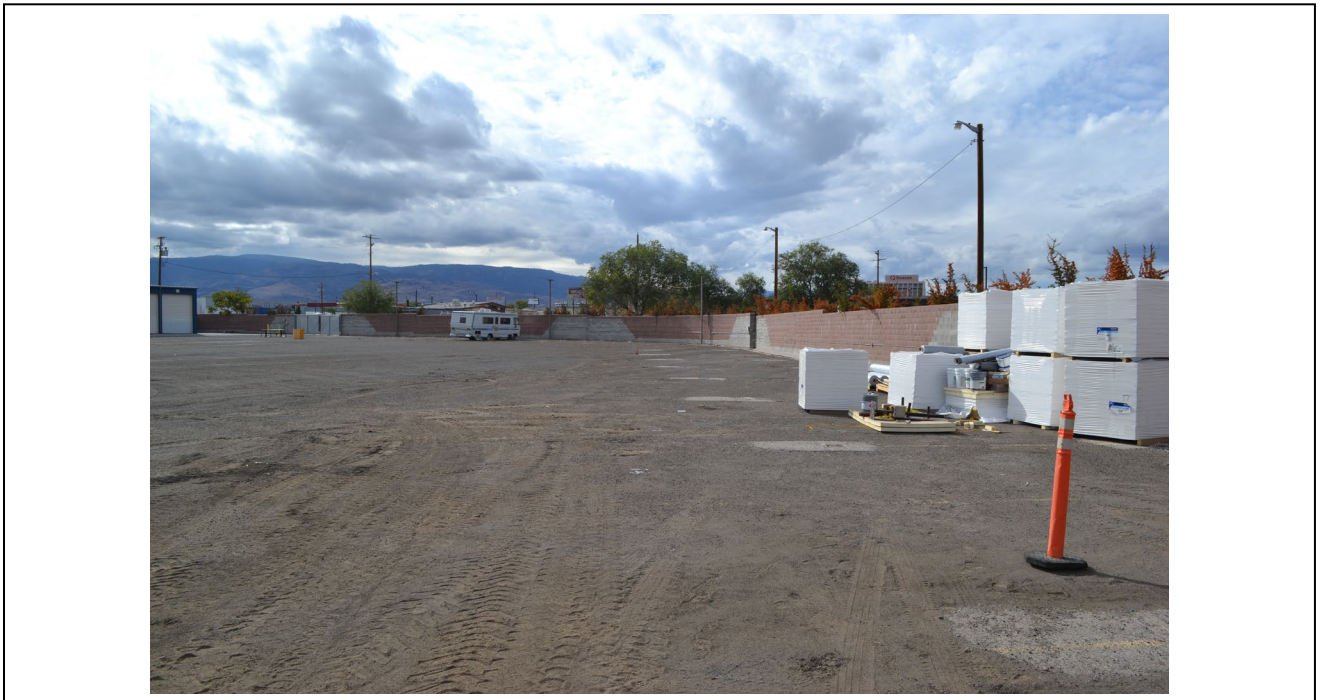
Elevation: Overview of CMU portion of Structure 2 Direction facing: 240
Photographer: S Rathbone Date: 10/25/2022

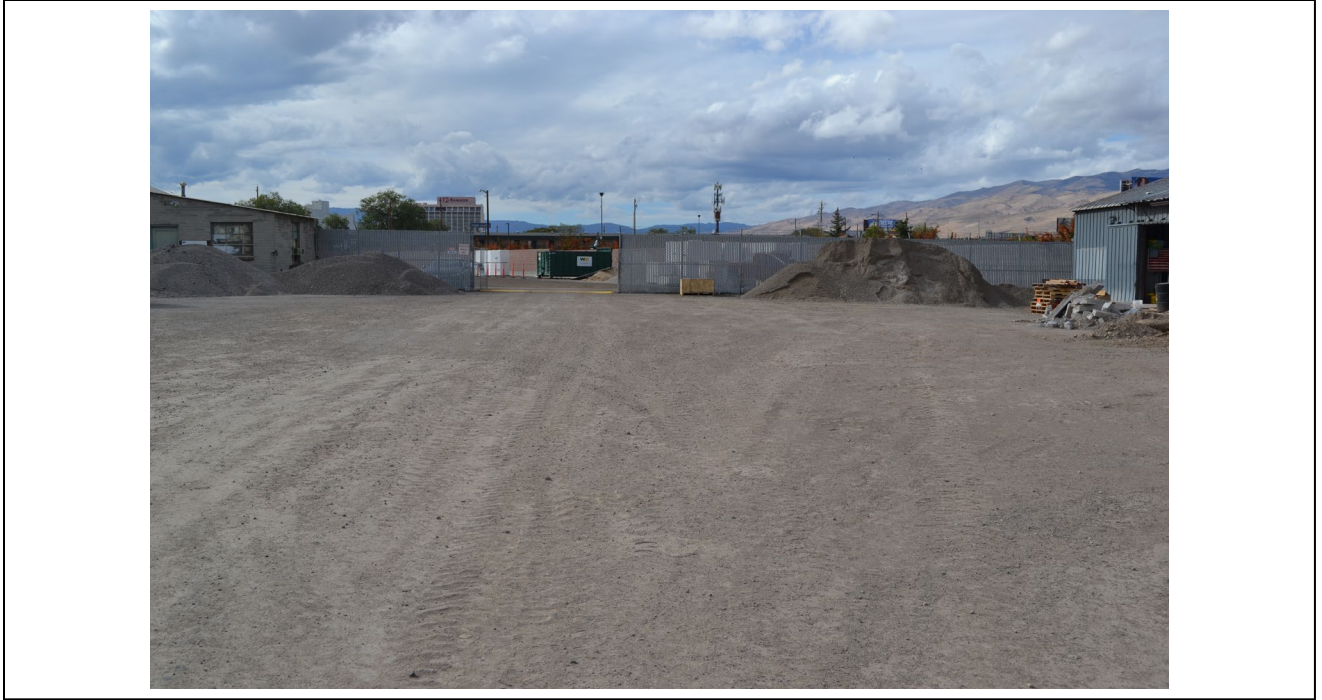
Elevation: Detail of Structure 3 running between Building 2 and Building 4
Photographer: S Rathbone

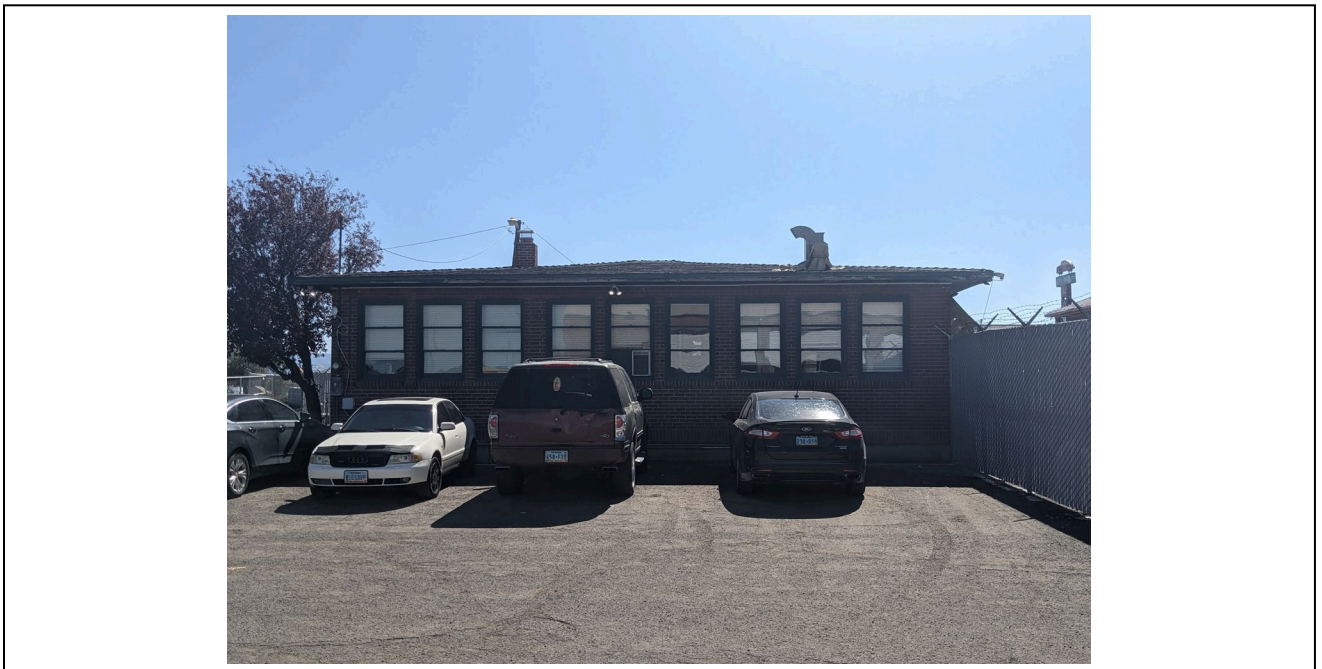
Elevation: B15585 Northern elevation
Date: 10/4/2022

The northern side wall features nine closely spaced wood frame, triple hung windows. A small electrical panel with a utility meter is located at the eastern corner of the wall. A small air conditioning unit is mounted in the bottom of the central window, with a wooden board blocking the rest of the opening.

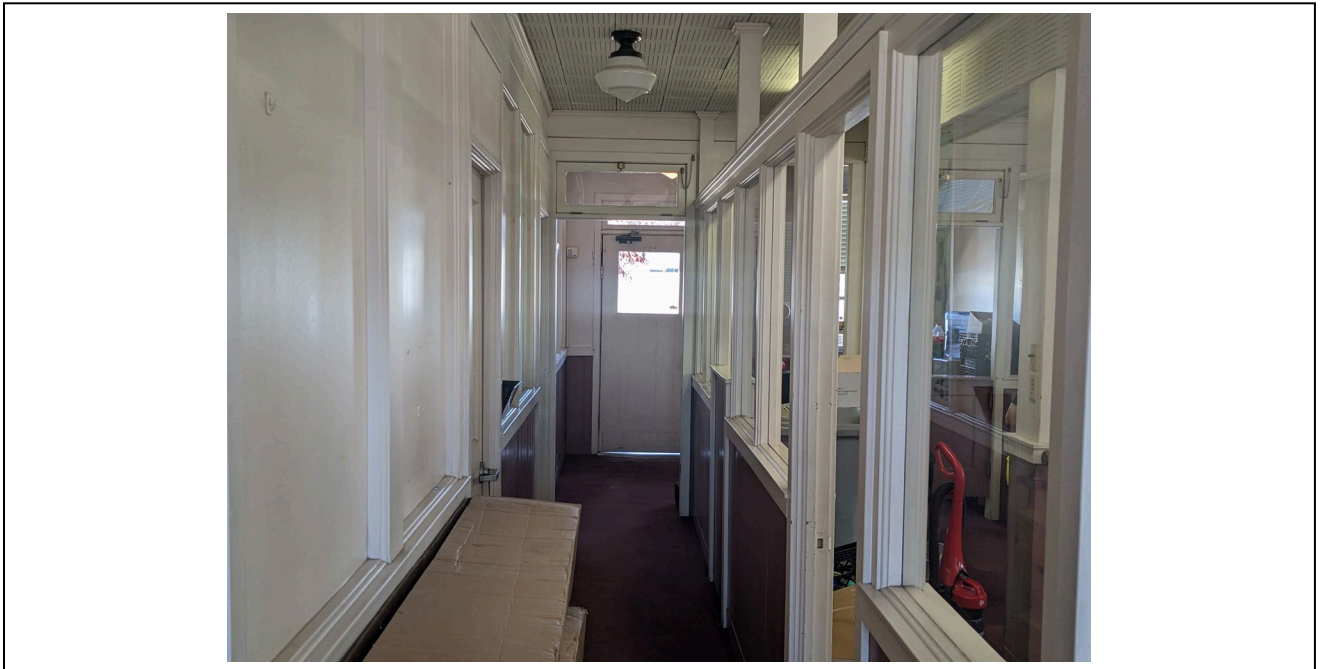
Elevation: B15585 Detail of largely intact interior
Date: 10/4/2022

The interior of the building is well preserved, and features a foyer, a passage, a large open plan office to the south of the passage, and three private offices to the north of the passage. Within the large open plan office are a set of restrooms, and a door that opens on to the stairs that lead to the basement. The different internal areas are defined by original wood or wood and glass partition walls, which are in good condition. The interior now features a drop ceiling.

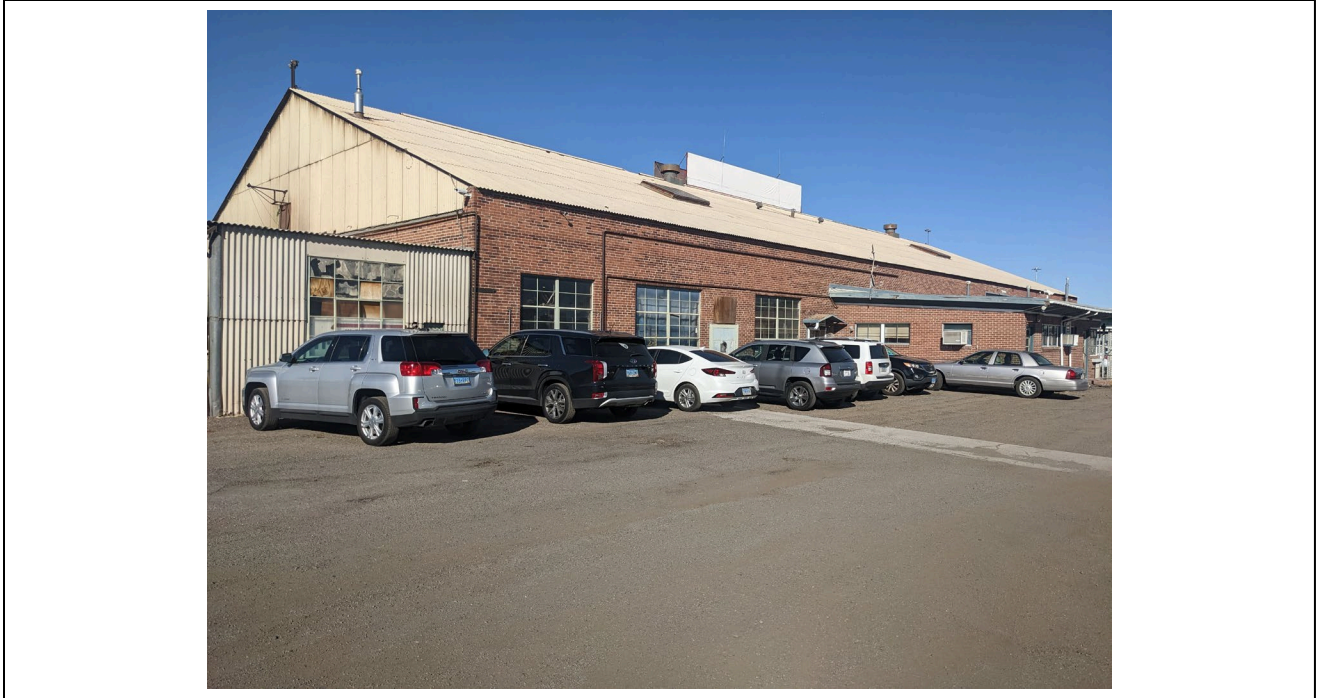
Elevation: Building 2 South elevation
Date: 10/4/2022

Building 2 is a large rectangular side gabled, metal frame, brick walled mechanics garage. The long axis of the two-story building is aligned east to west, and it is set upon a concrete pad foundation. The building is located to the west of Threlkel Street in the central part of the original freight yard. According to the Washoe County Assessor the building was constructed in 1946, and the building is visible in an aerial photograph dated to that year. Nova Geotechnical & Inspection Services recently produced a Phase 1 Environmental Site Assessment report of the site and identified Building 2 as having been constructed in 1942 (Nova Geotechnical & Inspection Services 2020:16). When originally constructed the building had a long and thin protruding boiler room in the center of the northern wall. By 1953 the building had acquired a small addition on the southern part of the western side wall, and by 1962 a single-story office block had been added to the center of the southern wall. By 1966 a small free-standing garage building had been constructed immediately west of the building. The small free-standing garage was demolished at some point after 1999, leaving only low concrete foundations.

The office addition extending from the center of the front facade features a wooden door with three horizontal lights in the upper half at the western corner, accessed from a wide concrete step. East of the door is a row of four adjacent metal frame 4-light awning windows, with one of the windows now housing a small air conditioning unit. Further east there is a second wooden door with three horizontal lights in the upper half, accessed from a wide concrete step. At the east of the wall there is a metal frame 9-light industrial style window with the upper 6-lights being an awning opening panel. The western side wall of the office addition features two adjacent metal frame 4-light awning windows towards the northern corner, and a metal frame 2-light window towards the southern corner that now houses an air conditioning unit. The eastern side wall of the office addition features two adjacent metal frame 4-light awning windows towards the northern corner, and a metal frame 2-light window towards the southern corner that now houses an air conditioning unit. The windows on the office addition have rowlock brick windowsills.

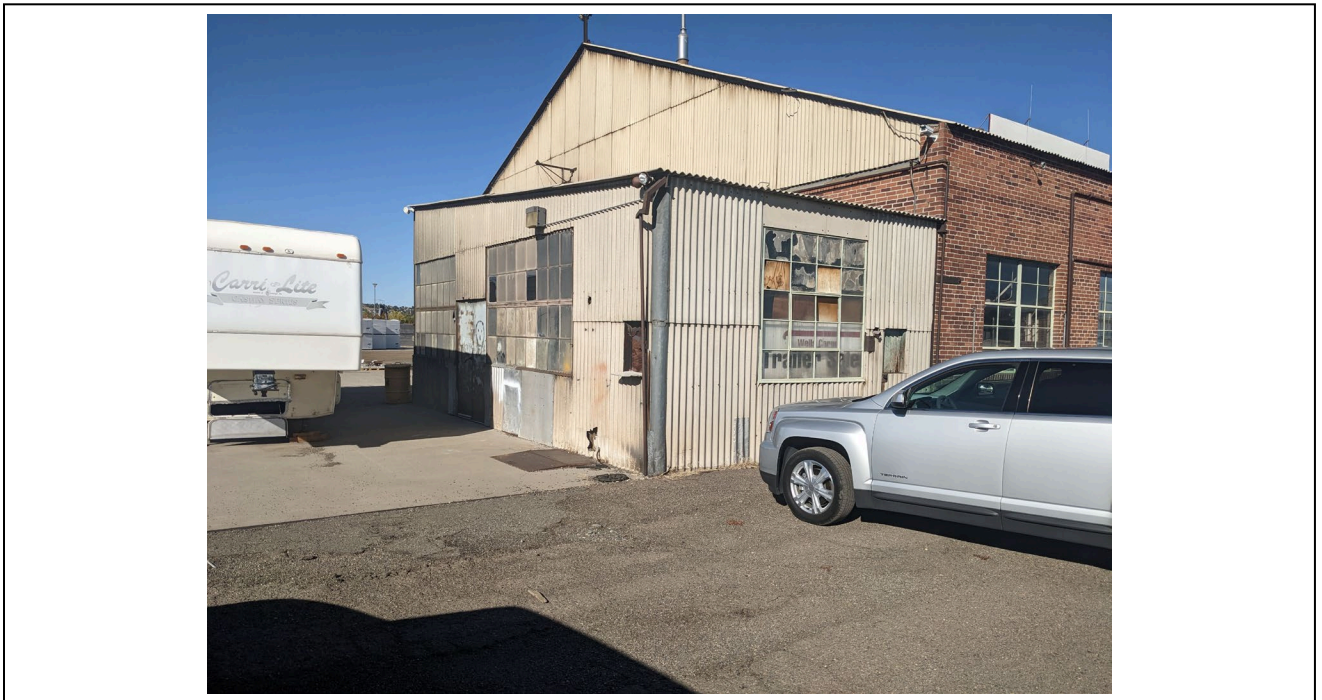
Elevation: Building 2 West Wall Addition
Date: 10/4/2022

The northern side of the addition on the western gable wall extends up to the base of the gable, and its roof slopes down to the south. The walls of the addition are clad in corrugated asbestos-cement panels, with some replacement galvanized corrugated sheets. The northern wall features a centrally positioned metal frame 32-light industrial style window with a 4-light center pivot panel. The western wall features a centrally positioned wide plain metal door, flanked by two metal frame-

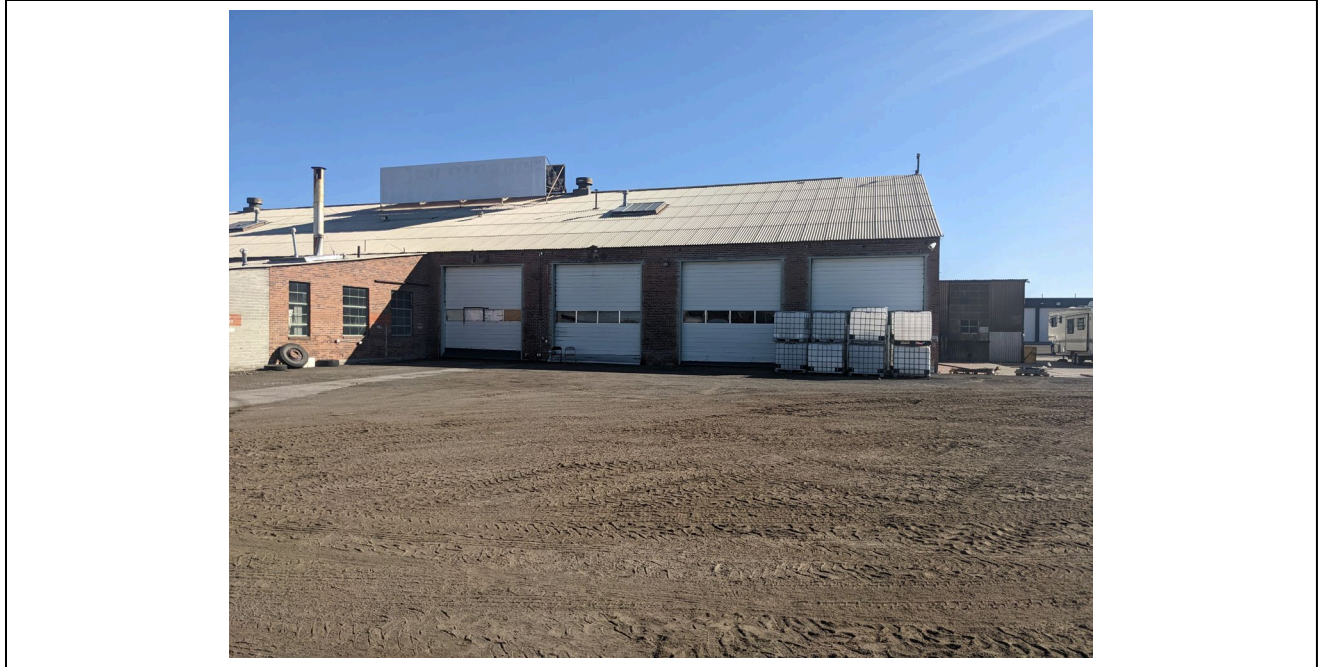
Elevation: Building 2 North elevation
Date: 10/4/2022

The northern rear wall is divided into two equally sized parts by the long and thin projecting boiler room that extends out to the north. The western section of the rear wall features four large garage bay doors with replacement overhead roller doors. The eastern section of the rear wall features four large garage bay doors with replacement overhead roller doors. At the eastern corner there is a smaller garage bay door which features a wooden 30-panel door, with 12-lights in its upper panels. The door is now permanently closed, and a crude set of plywood shelves has been attached to the lower part of the door. Metal handles low down on the door indicate that it raised upwards, but the lifting mechanism could not be determined. It is likely that the similarly sized and positioned blocked garage bay at the east end of the front façade originally featured a similar 30-panel wooden door.

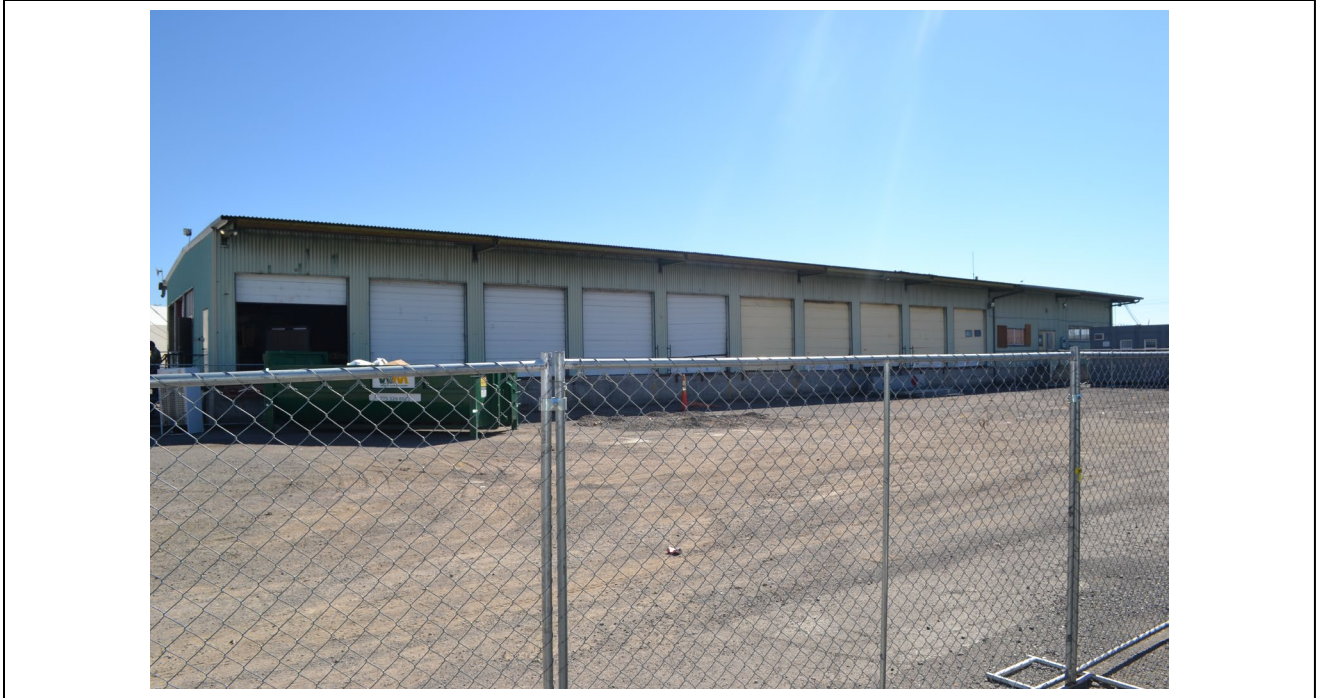
Elevation: Building 3 West elevation
Date: 10/4/2022

Building 3 is a large rectangular side-gable metal frame trucking transfer station. The building is clad with vertical ribbed metal siding, and it is set upon a raised concrete plinth foundation. The building is located to the east of Threlkel Street, in the southwestern portion of the extension to the freight yard. According to the Washoe County Assessor the building was constructed in 1964, and the building is visible in an aerial photograph dated to 1966.

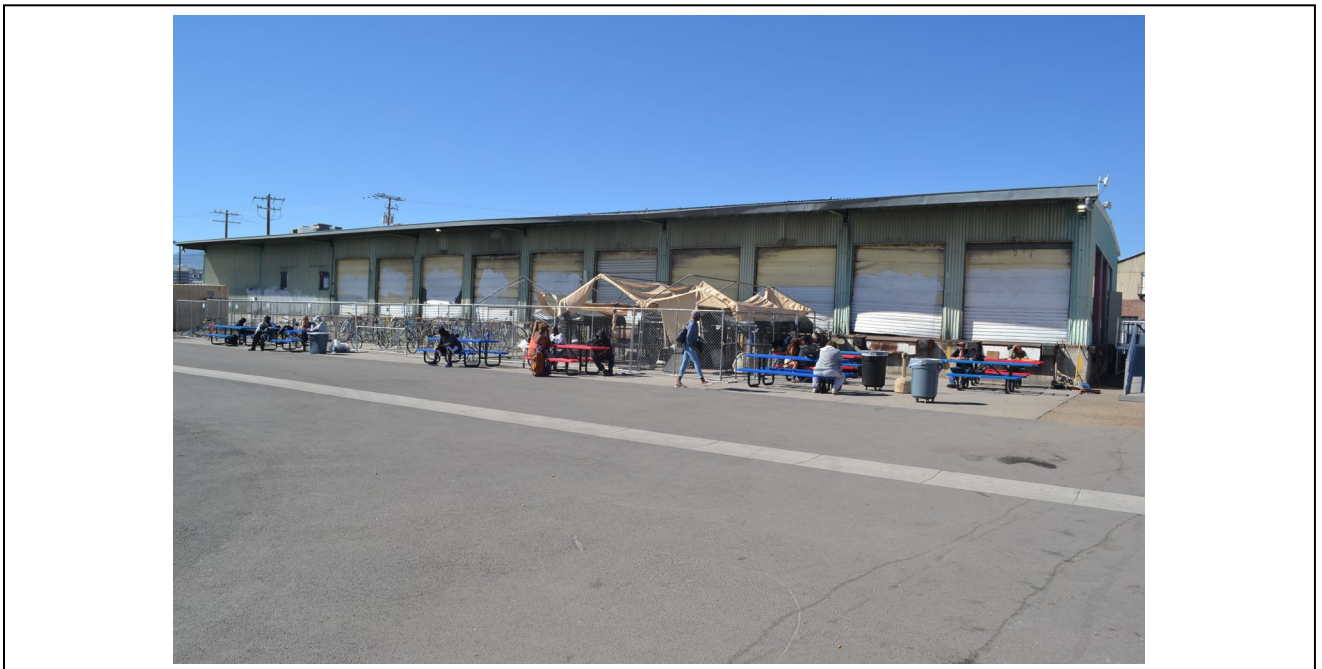
Elevation: Building 3 East elevation
Date: 10/4/2022

The rear wall at the east features ten regularly spaced large loading bay doors with overhead roller doors, which occupy most of the wall apart from the southern portion. The loading bay doors feature folding metal loading ramps with large rubber bumpers. The loading ramps are mounted at the top of the concrete plinth foundation, approximately four foot above the surrounding ground surface. The southern section of the wall, beyond the loading bay doors, features two medium sized metal frame 2-light sliding windows. The northern window is boarded up and the southern window is protected by a heavy metal mesh.

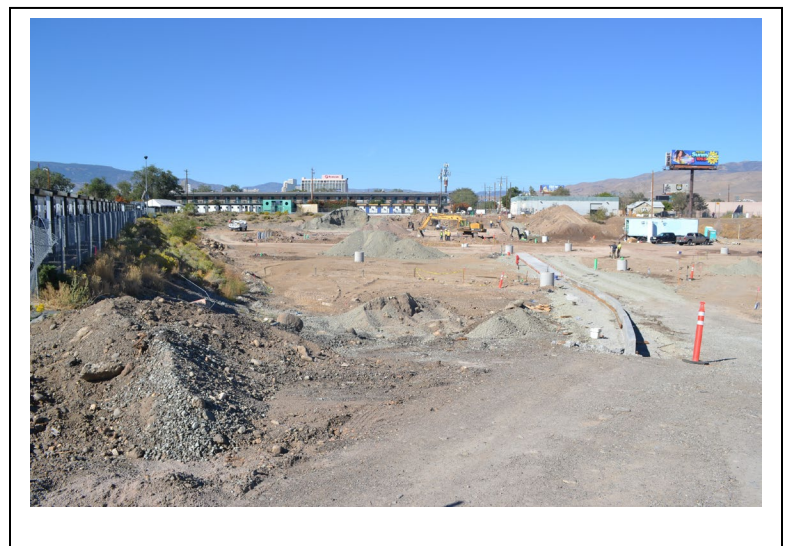
Construction Date	1972-1978		
Architectural Style	N/A		
Architectural Type	Baseball field		
Roof Form	N/A		
Roof Materials	N/A		
Exterior Wall Materials	N/A		
Foundation Materials	N/A		
Window Materials	N/A		
Window Type	N/A		
Accessory Resources?	Yes <input checked="" type="checkbox"/>	No <input type="checkbox"/>	
Number?: 4

Condition of Resource(s)?		
Good <input type="checkbox"/>	Fair <input type="checkbox"/>	Poor <input checked="" type="checkbox"/>
Explanation: The Governor's Bowl Park is being redeveloped and is currently an active construction site.

When surveyed in October 2022 the site was found to be in a much-altered condition, and no longer recognizable as a baseball field. The playing field was no longer extant, with up to 12-foot of fill material having been deposited to create a new building surface for the Safe Camp facility. The banks around the playing field and the low chain link fences at the tops of the banks are still present but the bleachers, floodlights, and the backstop have all been removed. The paths along the tops of the banks at the south and west are currently the location of 'Mod Pods', small 8-foot square prefabricated residential units.
